ARCHITECTURAL ASSESSMENT

The current facility was constructed at three different times:

- 1974 – Original
- 1984 – Middle bays
- 1998 – Apparatus Bay for Tower

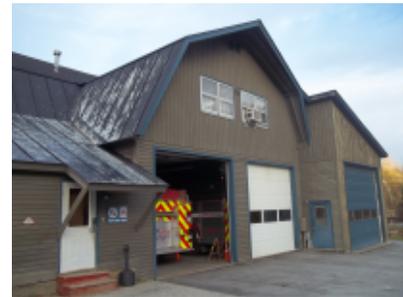
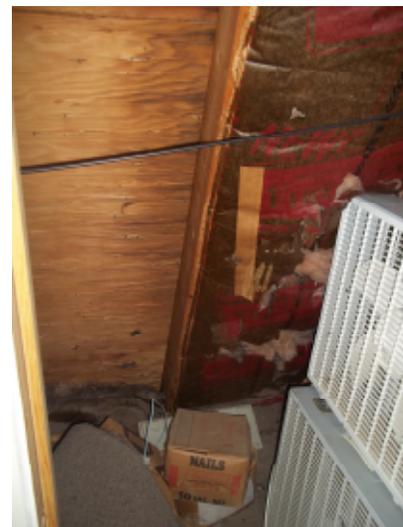
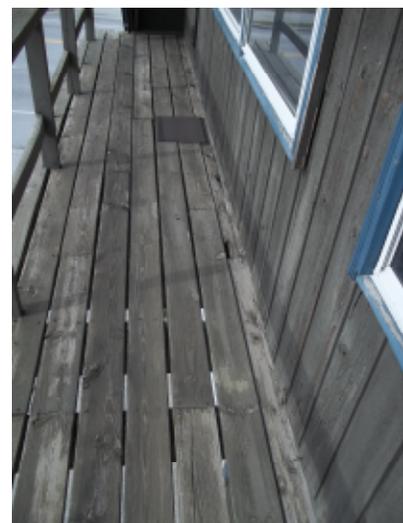
- The exterior consists of a one story 2 x 6 inch wood stud structure with stained wood siding and a single sloped roof
- There is approximately 5 ½ inches of batt insulation. We were not able to see the condition of the roof insulation. Approximate insulation value of R 10

- Most of the exterior siding and trim needs to be painted

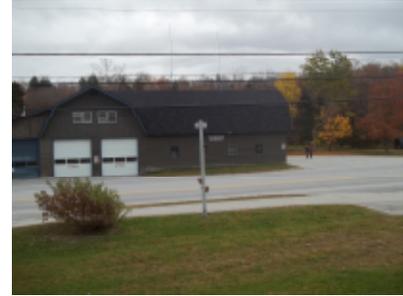
- Shingles appear to be in decent shape. We do not know how much is left on the warranty
- The metal roof is not in very good shape and needs replacement and/or painting

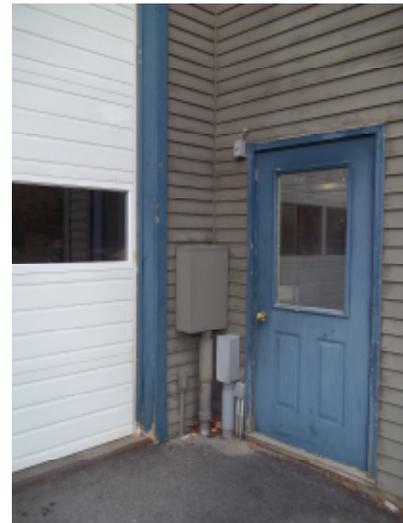
- The exterior man doors are not in very good shape.
- They are not commercial grade and may not be well insulated.
- Several man doors will take a lot of abuse by responders and should have commercial grade hardware.

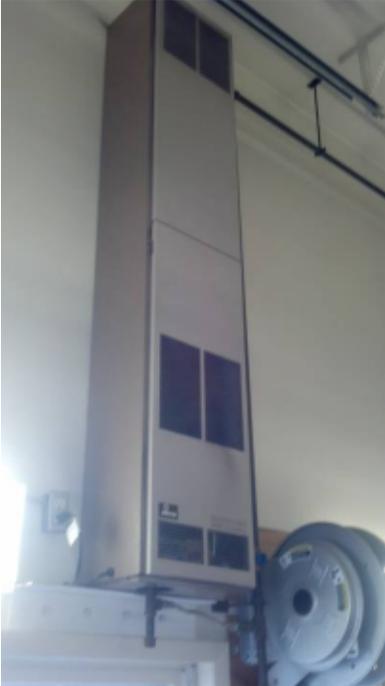
Empire Heating System Propane Heater

- The fire department is heated with propane gas furnaces. The furnaces appear to be original to the years they are installed (1974, 1984 and 1999). There are two (2) types of gas furnaces. The first is a wall mounted Empire Comfort Systems wall furnace. This type serves 2 of the engine bays and the upper level. The second furnace is a horizontal unit heater type and this model only serves the central engine bay.

1. There appear to be no issues with the mechanical systems. Some of the gas heaters are getting old and have cosmetic damage, but appear to be heating the building. More energy efficient models are available and the units should be upgraded when the existing units fail or need to be replaced.
2. According to the staff, the Air Vac 911 systems appear to be in working order.

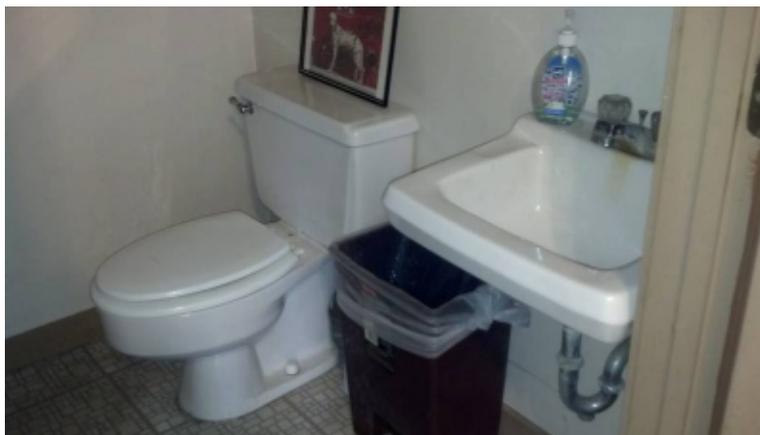
Existing Bathroom

- There is one lavatory on the first floor. It consists of a lavatory, water closet and shower. There are a couple of laundry sinks in the engine bays. Upstairs this is a kitchen sink.

1. Replace existing plumbing fixtures with low water consumption models. The water closets can be reduced to 1.6 gpf and aerators can be installed on the lavatory faucets. This will reduce water consumption.

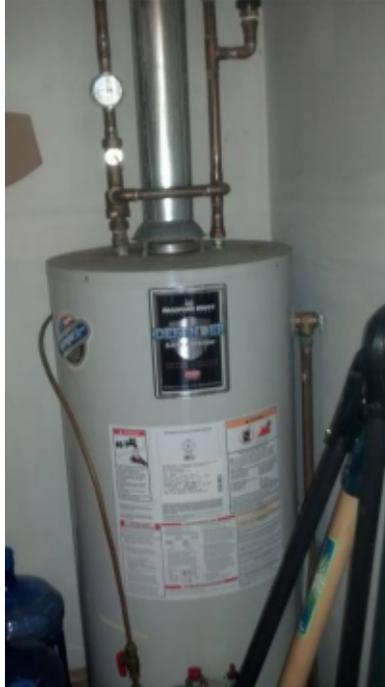
- A fairly new water heater is installed with a tempering valve, so it is meeting the current plumbing code requirements.

New Water Heater with Tempering Valve

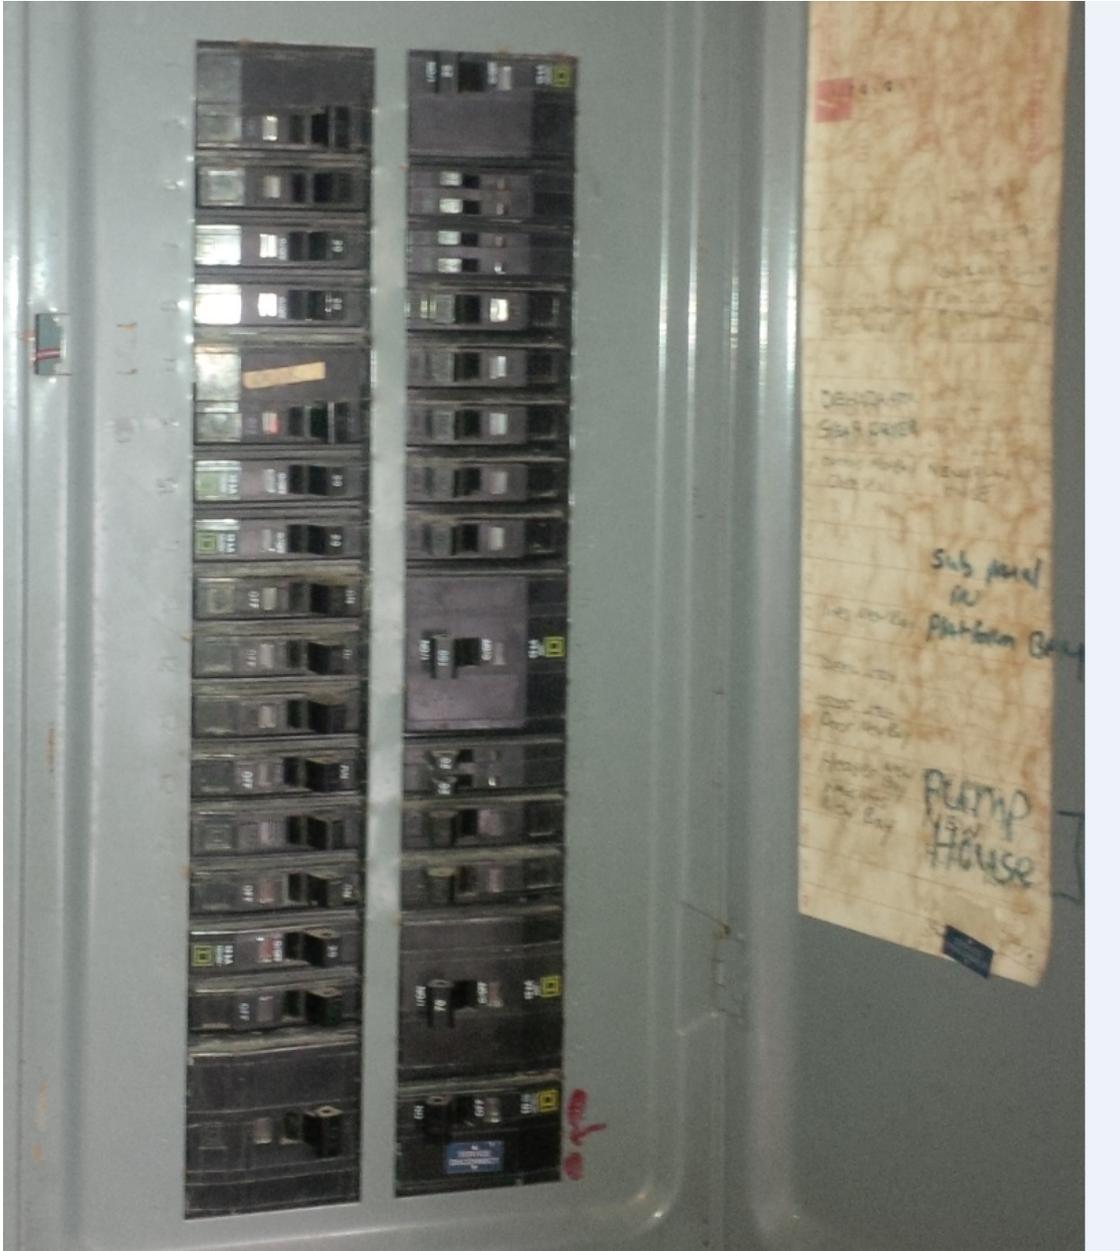
This Square D main panel distributes power to a 100 amp subpanel in the 1998 addition, and a smaller 60 amp subpanel in the day-room upstairs. It also provides power to the small pump house near the brook. The panel also provides power to a 15 HP pump that is used to fill the trucks from the water reservoir under the apparatus bay. This panel and breakers are not well labeled and the accuracy of the panel schedule is suspect. The panel is completely full and there are (6) mini breakers used which indicates that the panel is under sized and potentially over-loaded. See Figure #1 on page E-2.

This main panel is in need of replacement and should be relocated. Electrical distribution equipment and wiring is expected to last ~40 years. This original panel, breakers, and distribution wiring are approaching this age. The existing equipment is at an age where failures are expected.

Figure #1
Main Panel full with mini-breakers and poor labelling

The electrical service seems marginal at the present size of 200 amps. It is recommended that a new, larger size service be installed and that the 1984 distribution and 1974 distribution systems be replaced and increased to allow for more circuits and spare capacity. The 1998 addition panel and generator equipment are adequate and could remain.

The size of the existing service should be increased to allow for future expansion and additional loads. New panels and subpanels should be installed in the 1984 and 1974 portions of the building.

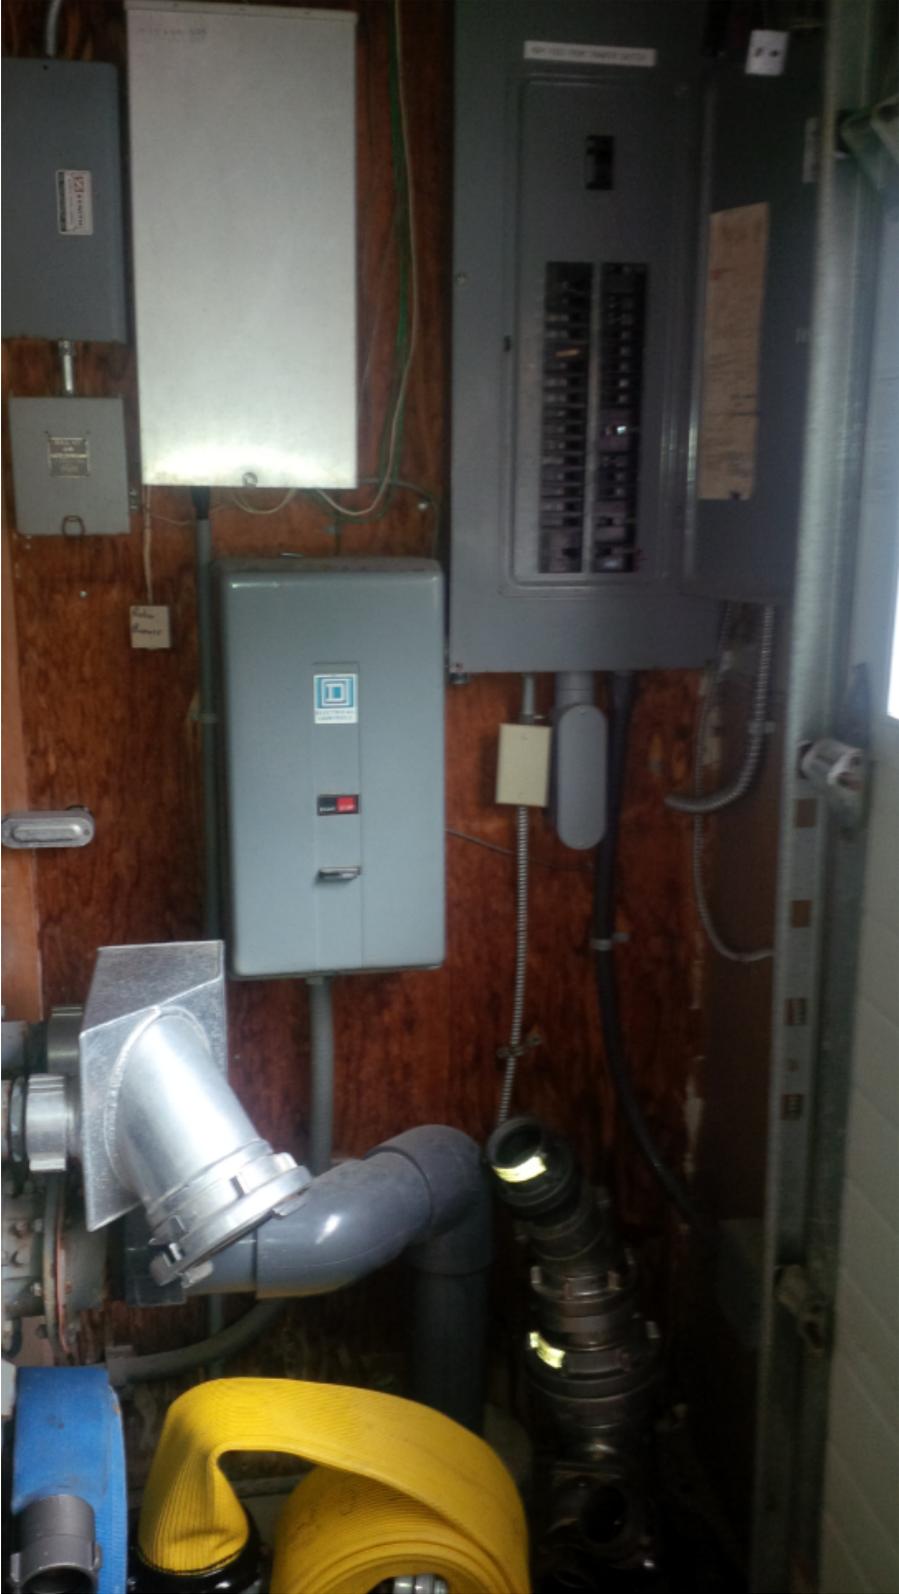
The main panel is located at the rear of the apparatus bay and does not have the code-required working clearances around it. Panels require a clear working clearance of 30" wide and 36" in front. The 15 HP pump and associated plumbing is blocking the clear access to the panel. See Figure #2 on page E-3.

Figure #2
Main Panel with inadequate working clearances, Telephone entry location

Phone and internet service is provided by VTel. The phone service enters the building next to the main

distribution panel. Refer Figure #2. The phone wiring runs up to an old AT&T Phone Spirit system in the radio room. From here, phone cables are run to all the phones. Most wiring is surface mounted and stapled to walls and strapped to conduits and other wiring. Refer to figures #3 and #4.

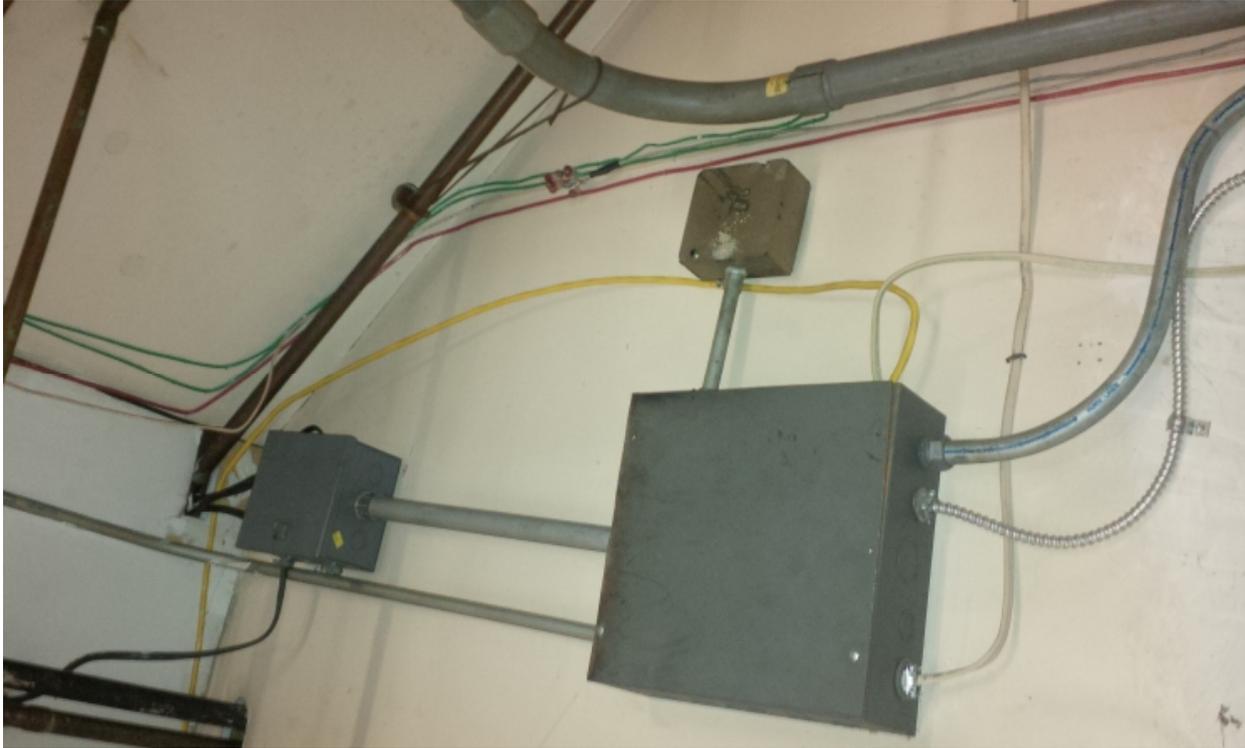
There is exposed, surface Romex in the 1974 building. See figures #3 and #4. Romex is not allowed to be exposed in garages. Romex is also laying on the floor, subject to damage, in the storage closets on the second floor. See figure #5.

Figure #3 showing surface Romex and messy phone wiring

All wiring in the 1974 and 1984 portions of the building should be completely removed and replaced.

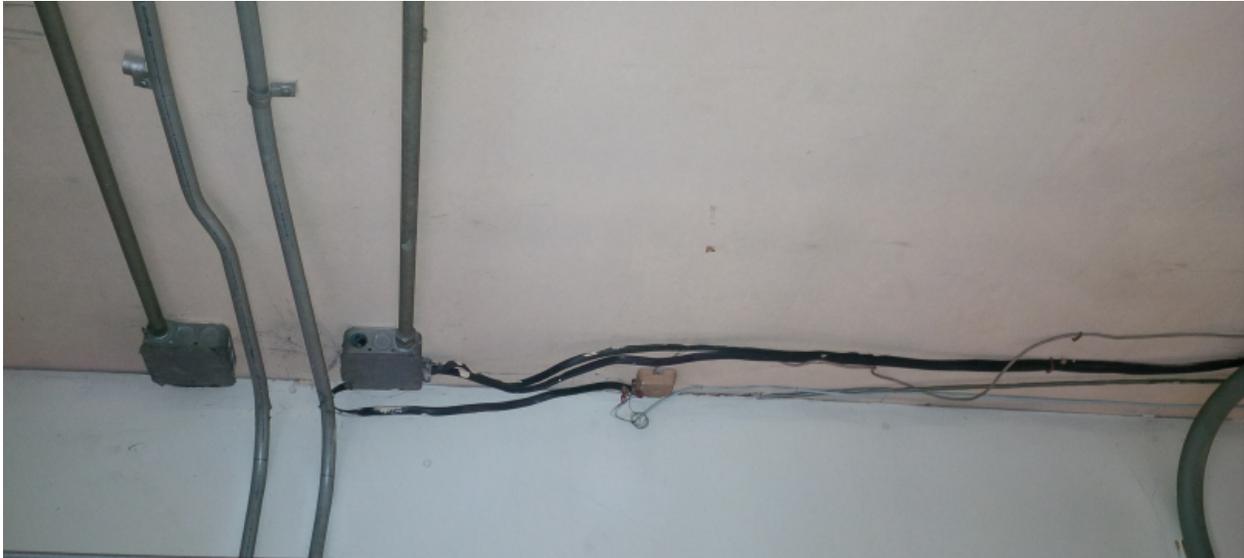
Figure #4 showing exposed Romex wiring and surface telephone wiring

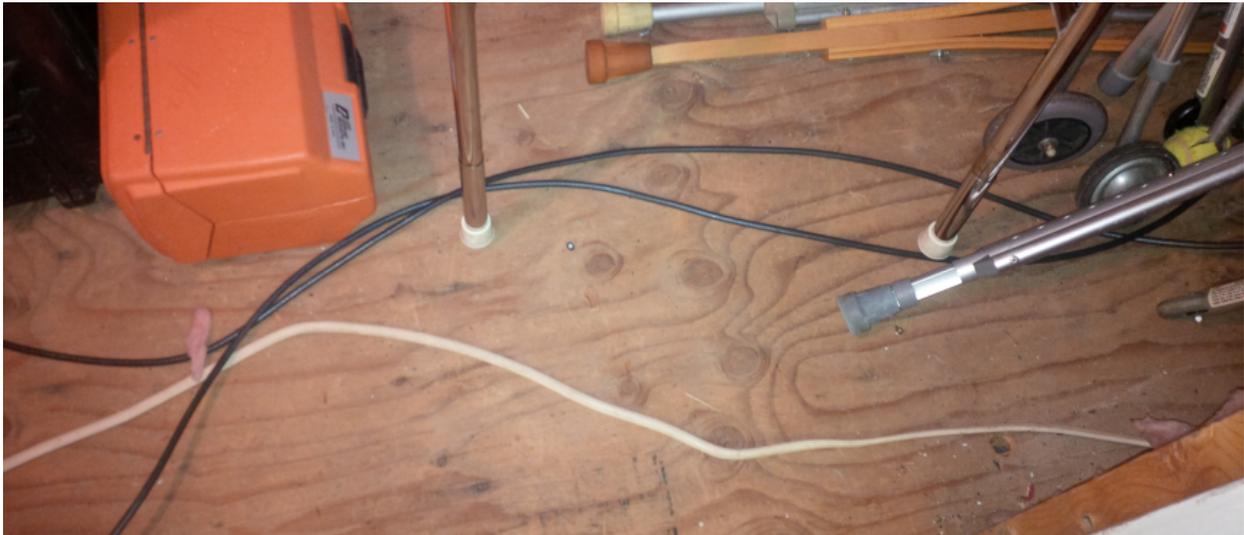
Figure #5 showing Romex and Antenna wiring lying on the closet floor.

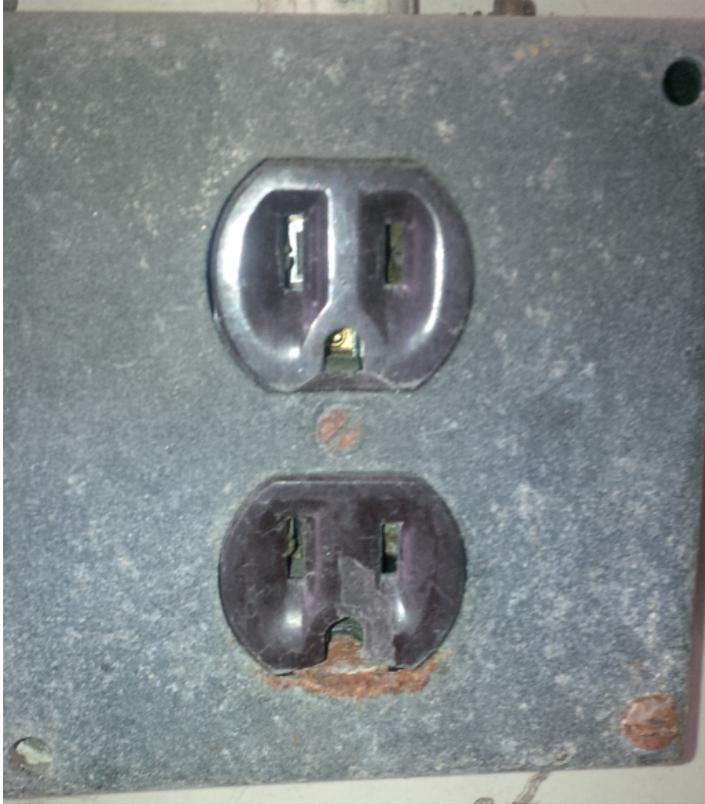
Most all the receptacles in the 1984 and 1974 building are broken. Refer to figure #6.

Figure #6 Showing typical a broken and worn-out receptacle

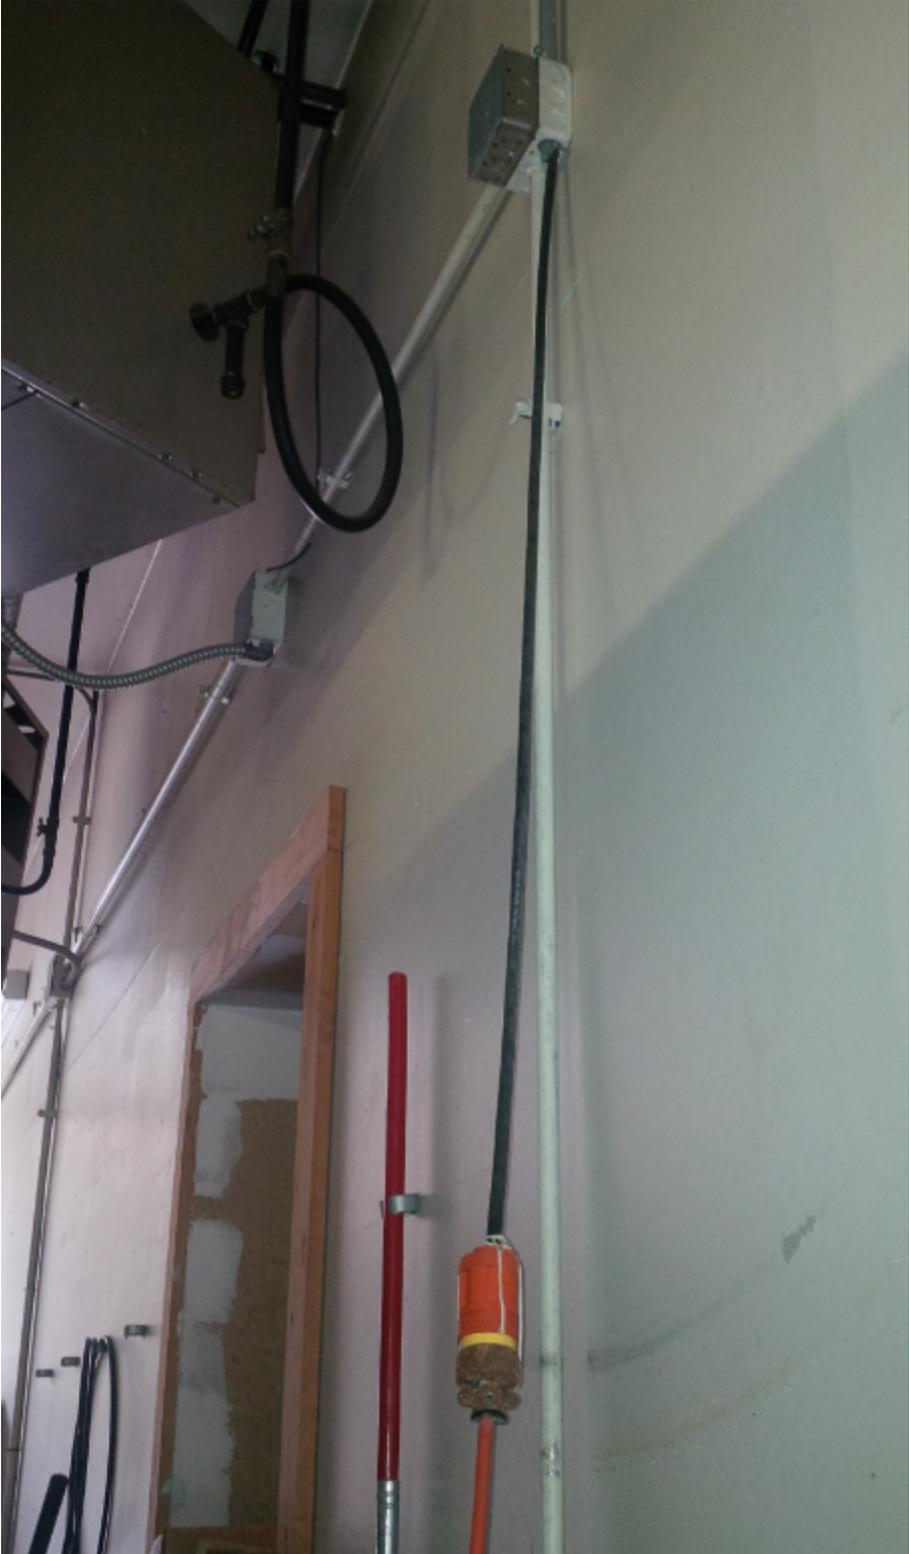
The cords feeding the trucks are not GFI protected. Many cords are in poor condition and strain-reliefs are not used to keep the cords from being pulled from the junction boxes. Refer to Figures #7 and #8.

Figure #7 showing no GFI or strain relief at the junction box

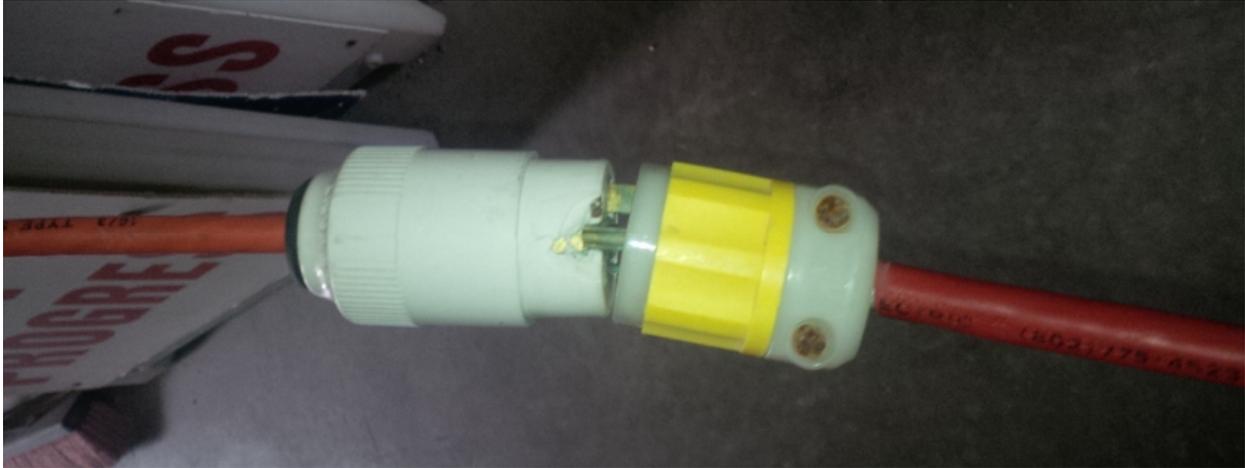
Figure #8 showing damaged cord connected to a truck

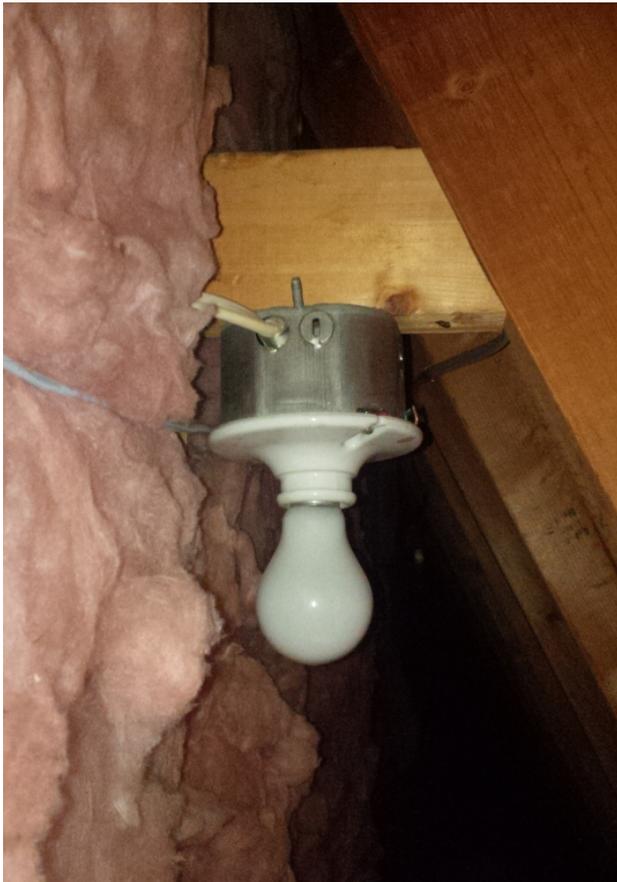
Figure #9

Another potentially dangerous situation occurs in the upstairs closets. Incandescent bare lamps are in very close proximity to uncovered insulation. All fixtures in closets are required to have protective lenses. Refer to Figure #9.
