Killington Road Walkway Scoping Study

Alternative Presentation Meeting
Town of Killington Planning Commission
May 13, 2015

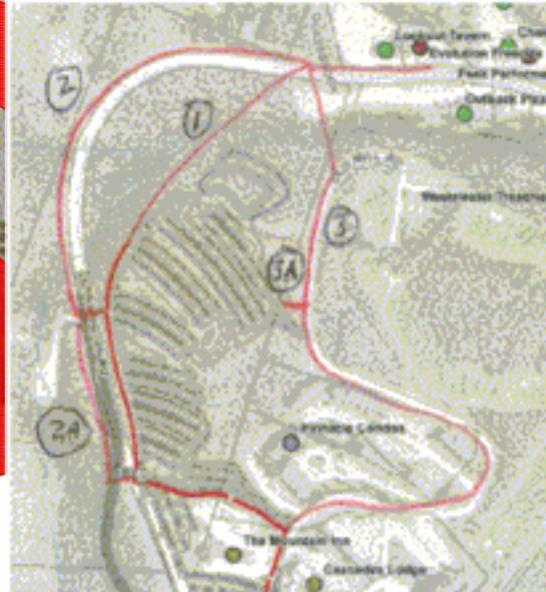
Environmental Constraints Review

Primary Concerns:

Roaring Brook and Tributary
Buffer

Historic Buffer

Wetlands

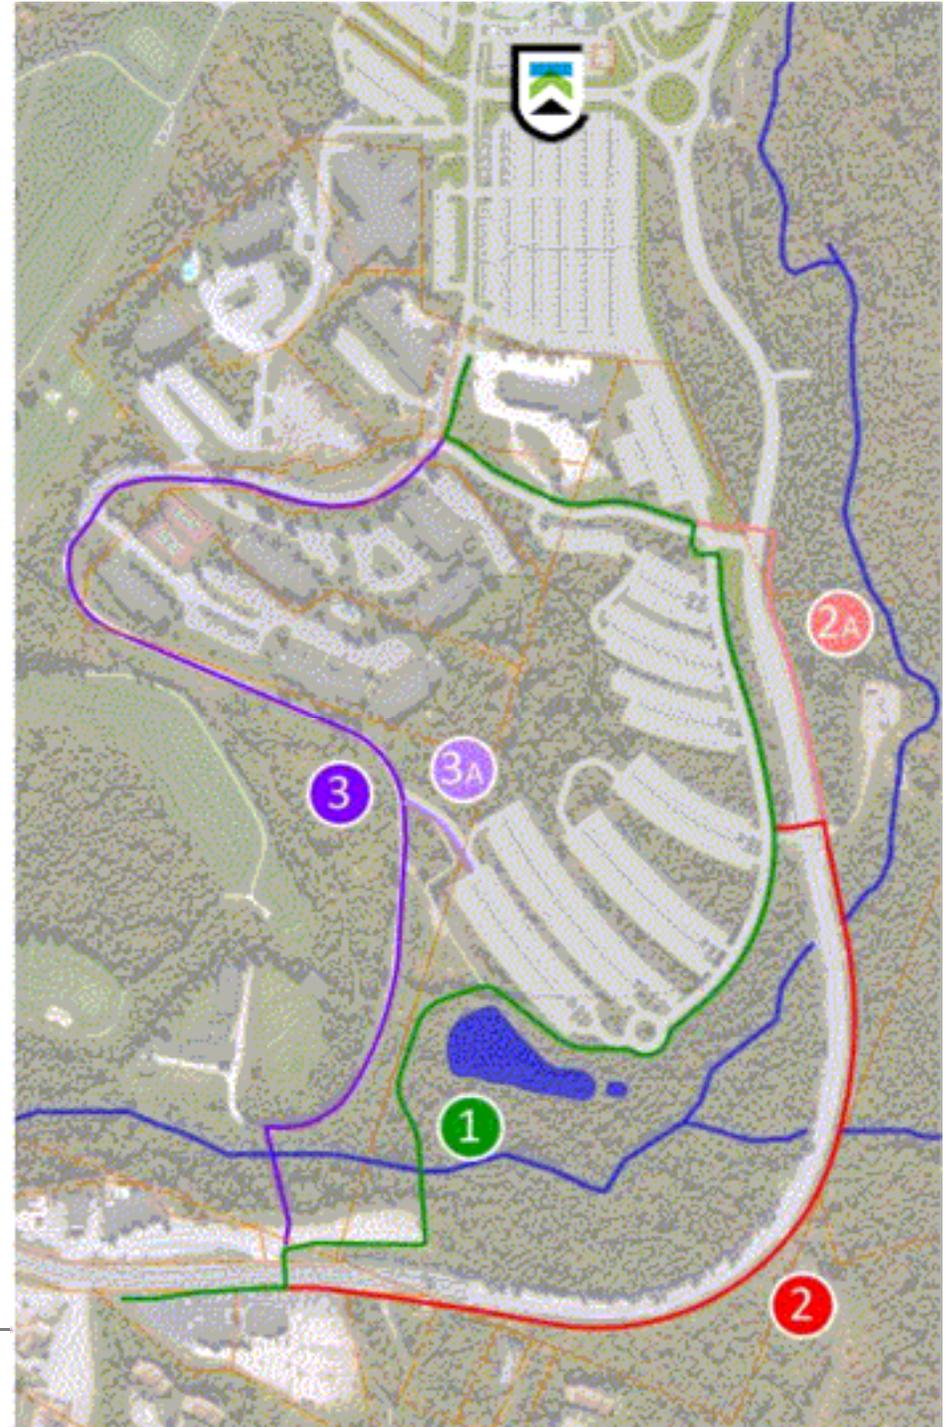
Three Walkway Alignments

Alignment 1:

Off-Road, through resort parking area

Alignment 2:

On-Road, west side of Killington Road

Alignment 3:

Off-Road, following Old Mill Road

All three alignments extend the walkway through the Lookout Tavern / True Wheels Bicycle lot

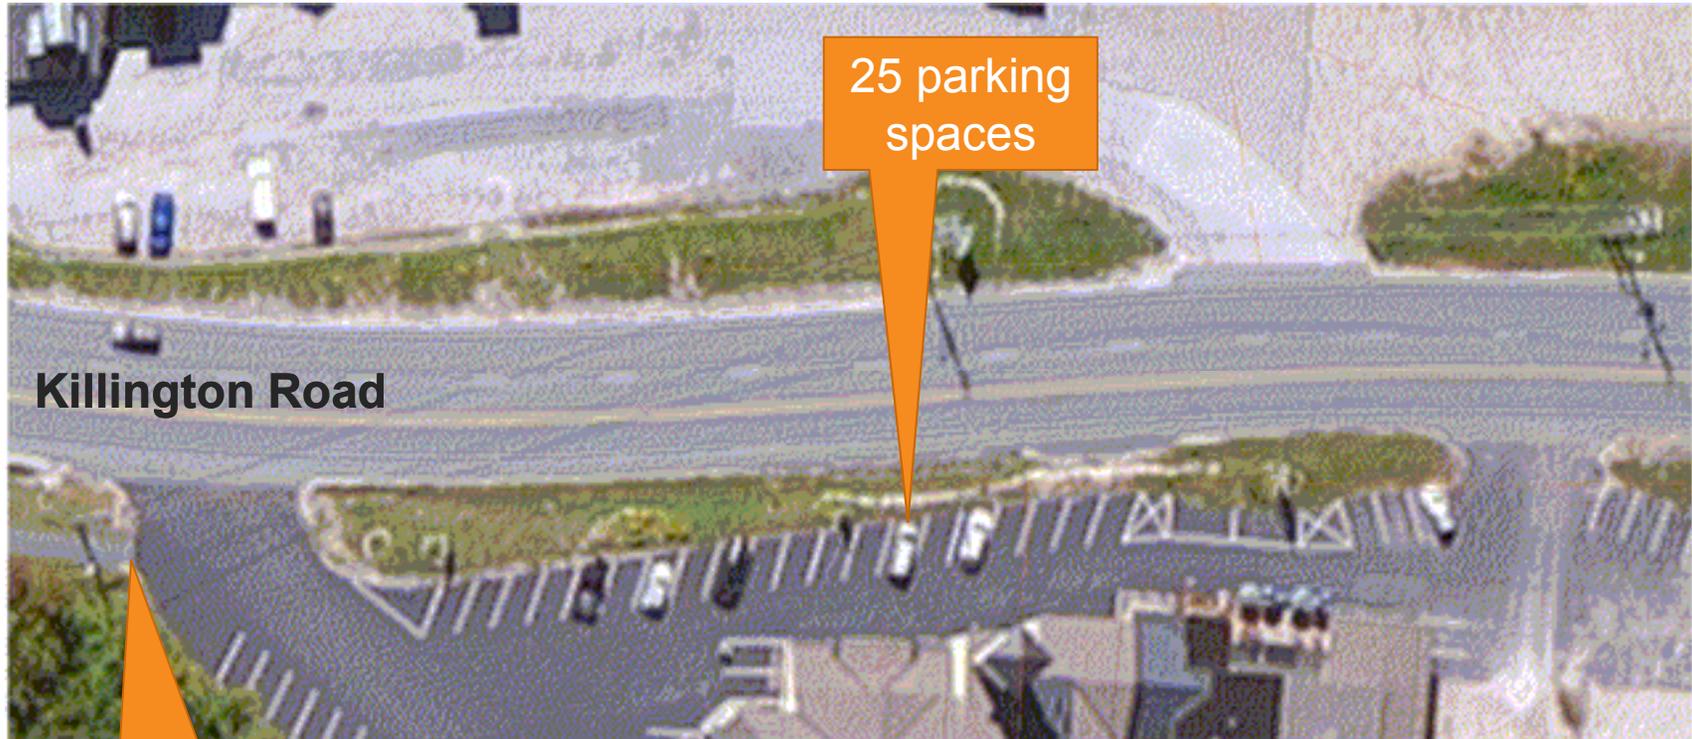
Common Alignment: Lookout Tavern – True Wheels Bicycle Lot

End of existing
walkway

True
Wheels

Lookout
Tavern

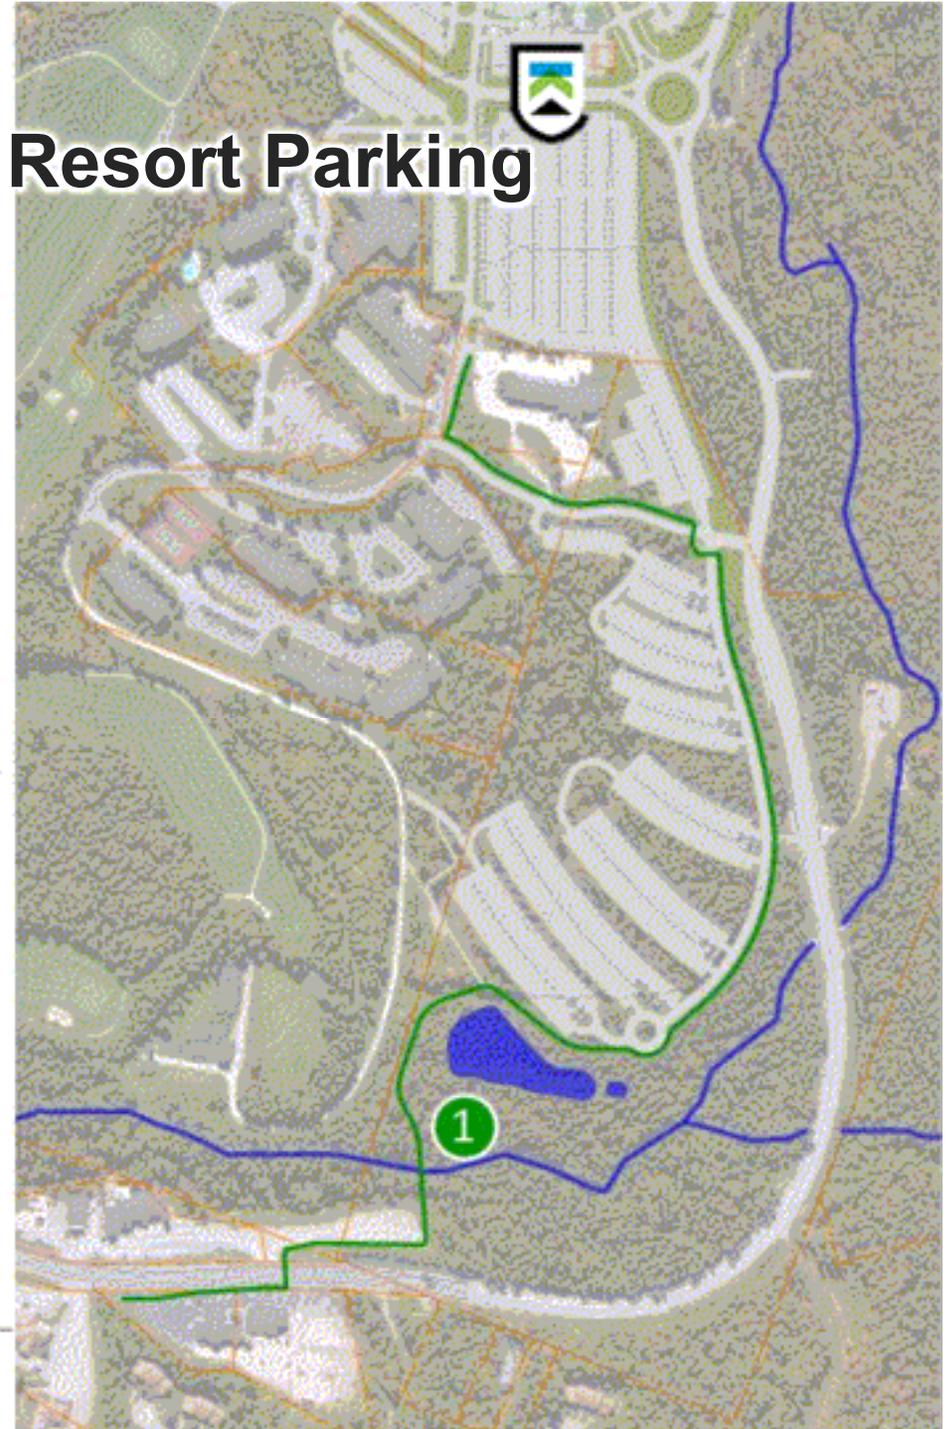
Alignment 1 – Through Resort Parking

- Overall Length – 4250 feet
- Almost half the walkway travels through the resort parking lots (2000 feet)
- Passes parking lot shuttle stop
- Crosses Killington Road at Lower Crossing Point
- New Stream Crossing
 - Assume 75-foot bridge
 - Impacts to Roaring Brook

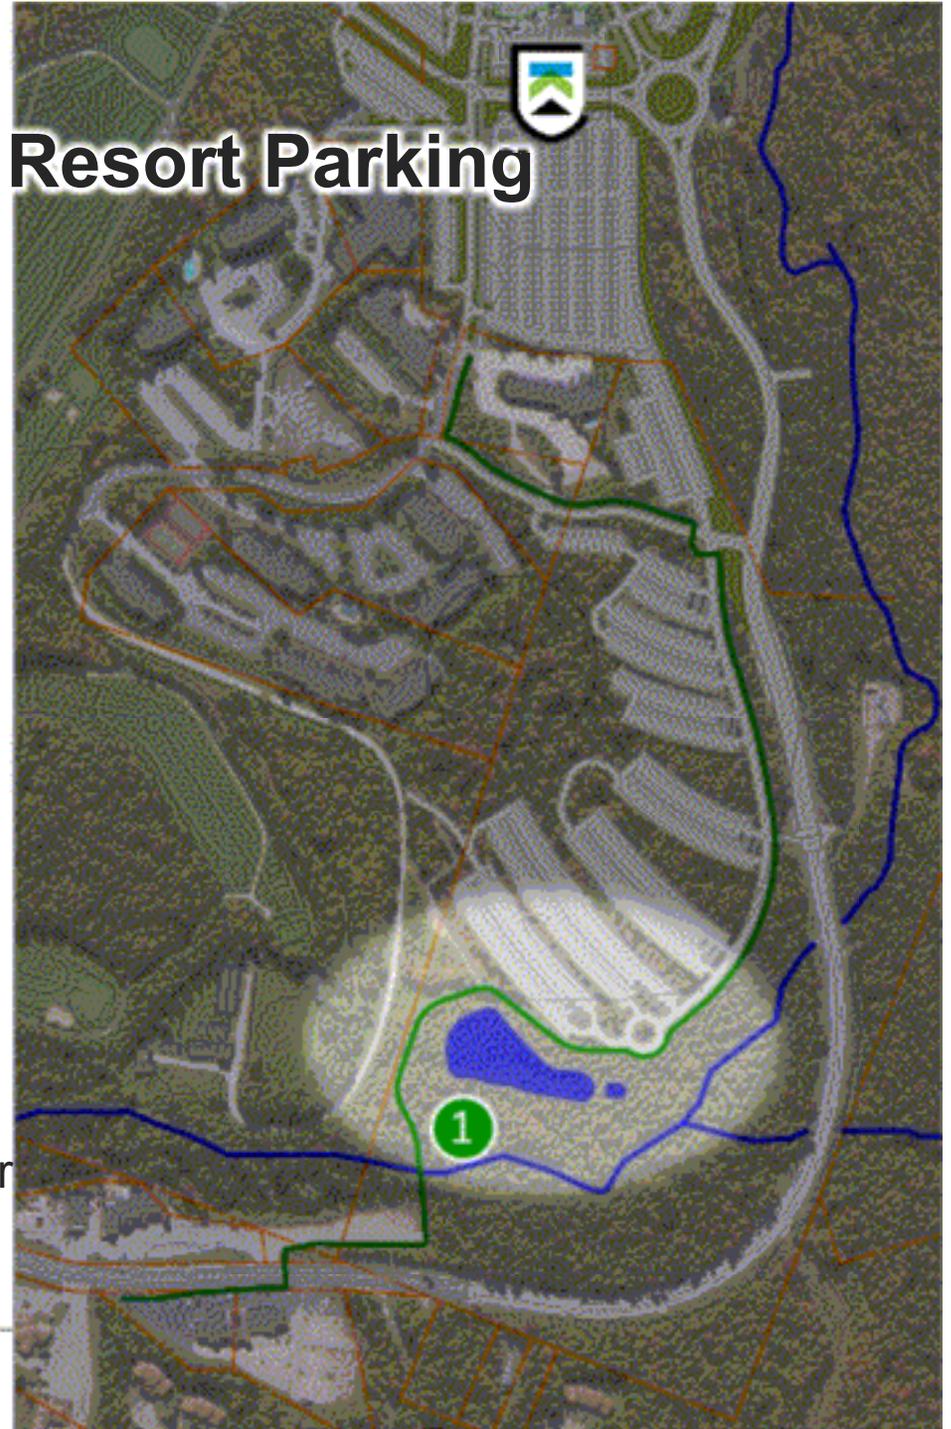
Alignment 1 – Through Resort Parking

- Overall Length – 4250 feet
- Almost half the walkway travels through the resort parking lots (2000 feet)
- Passes parking lot shuttle stop
- Crosses Killington Road at Lower Crossing Point
- New Stream Crossing
 - Assume 75-foot bridge
 - Impacts to Roaring Brook
- Steep Slope from river to parking lot
 - Approximately 8% grade
 - ADA recommended max is 5%
 - Site plan is very tight; no room for path without changes to pond or parking layout

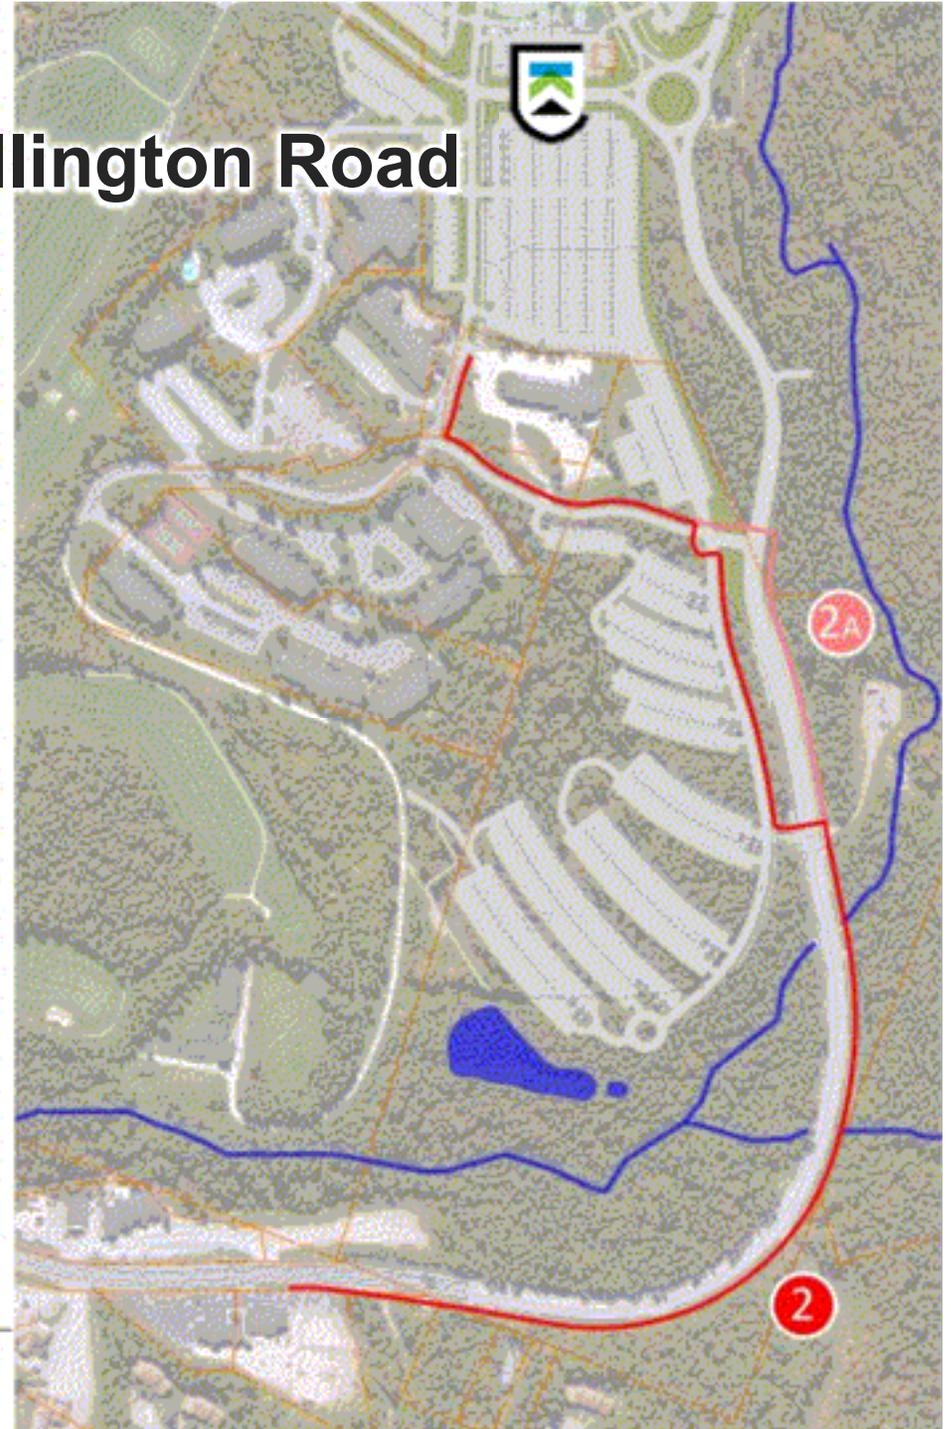
Alignment 2 – Along Killington Road

- Overall Length – 4400 feet
- Continues path along west side of Killington Road, ~6% grade
- Approximately 1650 feet of path travels through resort parking lot
- Behind the existing utility poles; 15-foot green strip

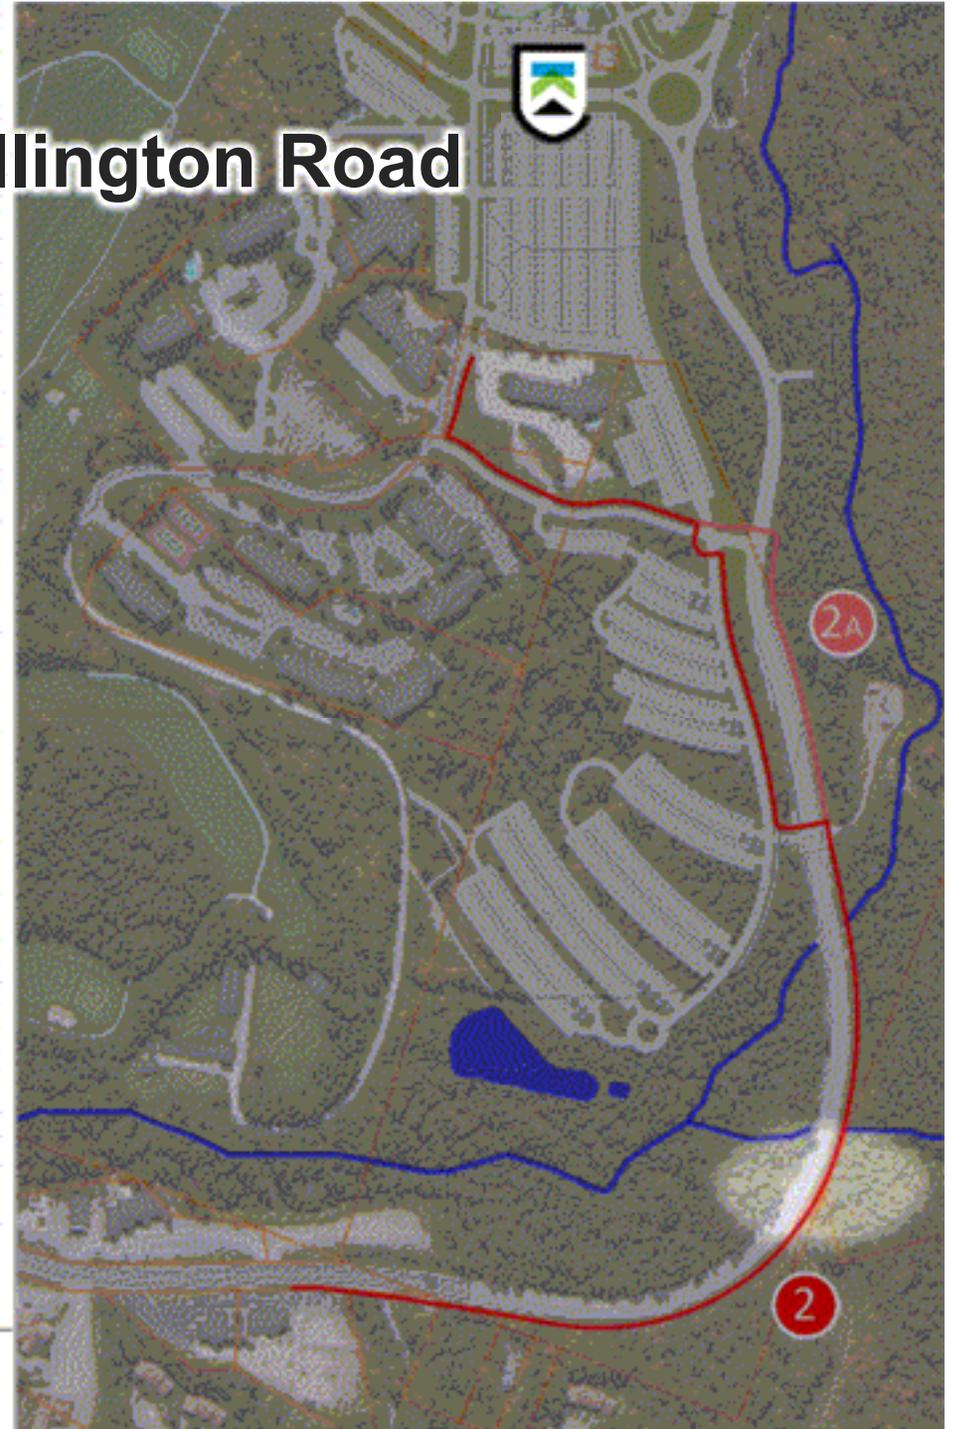
Alignment 2 – Along Killington Road

- Overall Length – 4400 feet
- Continues path along west side of Killington Road, ~5% grade
- Approximately 1650 feet of path travels through resort parking lot
- Behind the existing utility poles; 15-foot green strip
- Historic buffer impact
- Two large stream crossings
 - Assume box culvert extension
 - Impacts to river buffer

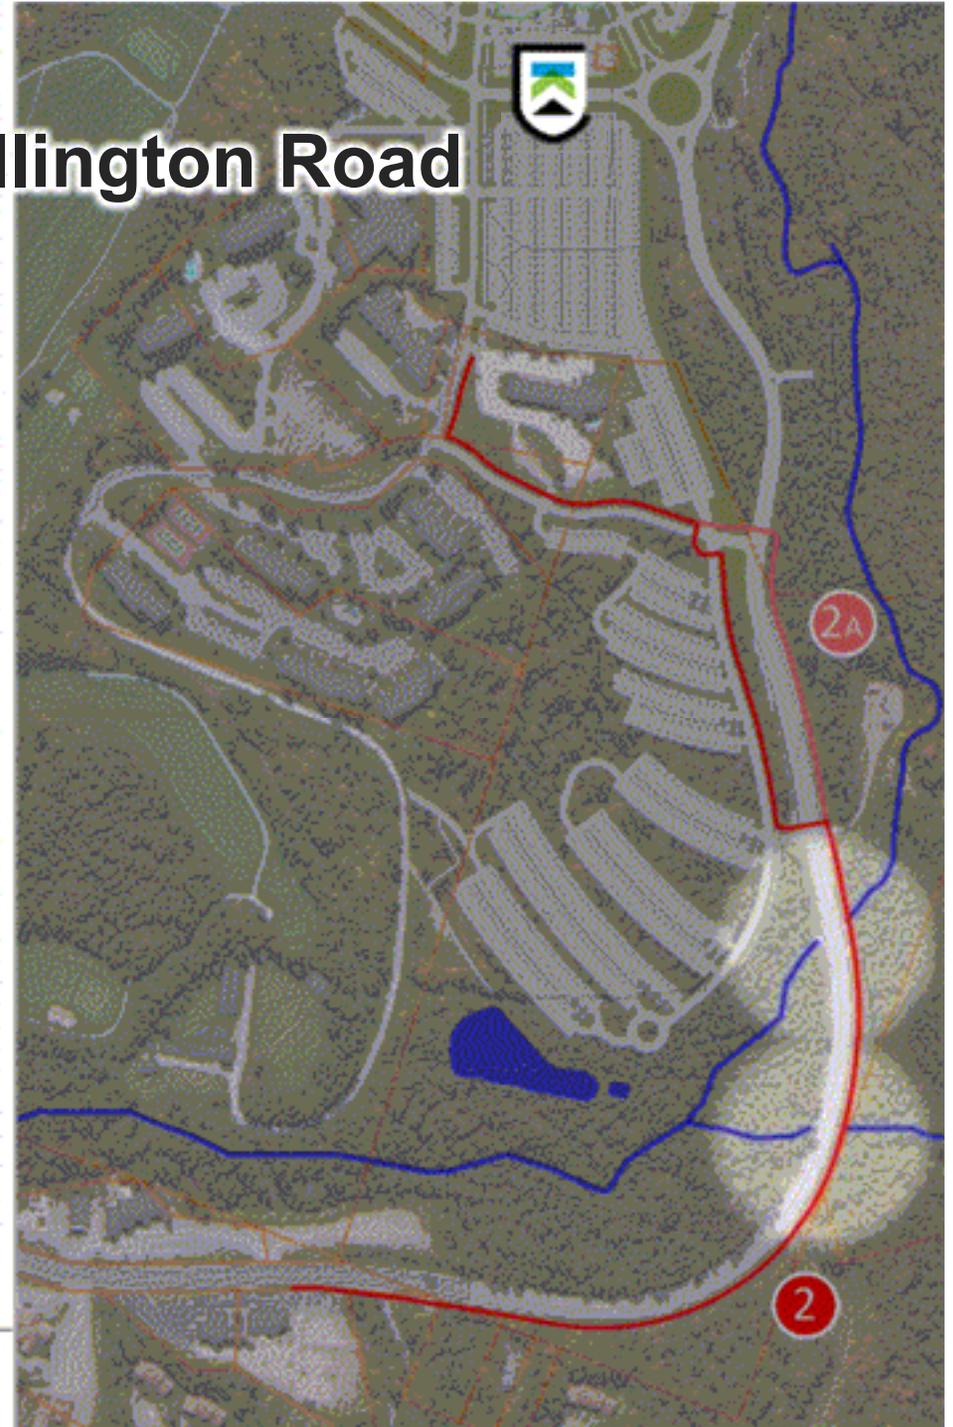
Alignment 2 – Along Killington Road

- Overall Length – 4400 feet
- Continues path along west side of Killington Road, ~5% grade
- Approximately 1650 feet of path travels through resort parking lot
- Behind the existing utility poles; 15-foot green strip
- Historic buffer impact
- Two large stream crossings
 - Assume box culvert extension
 - Impacts to river buffer
- Crosses Killington Road at first drive access

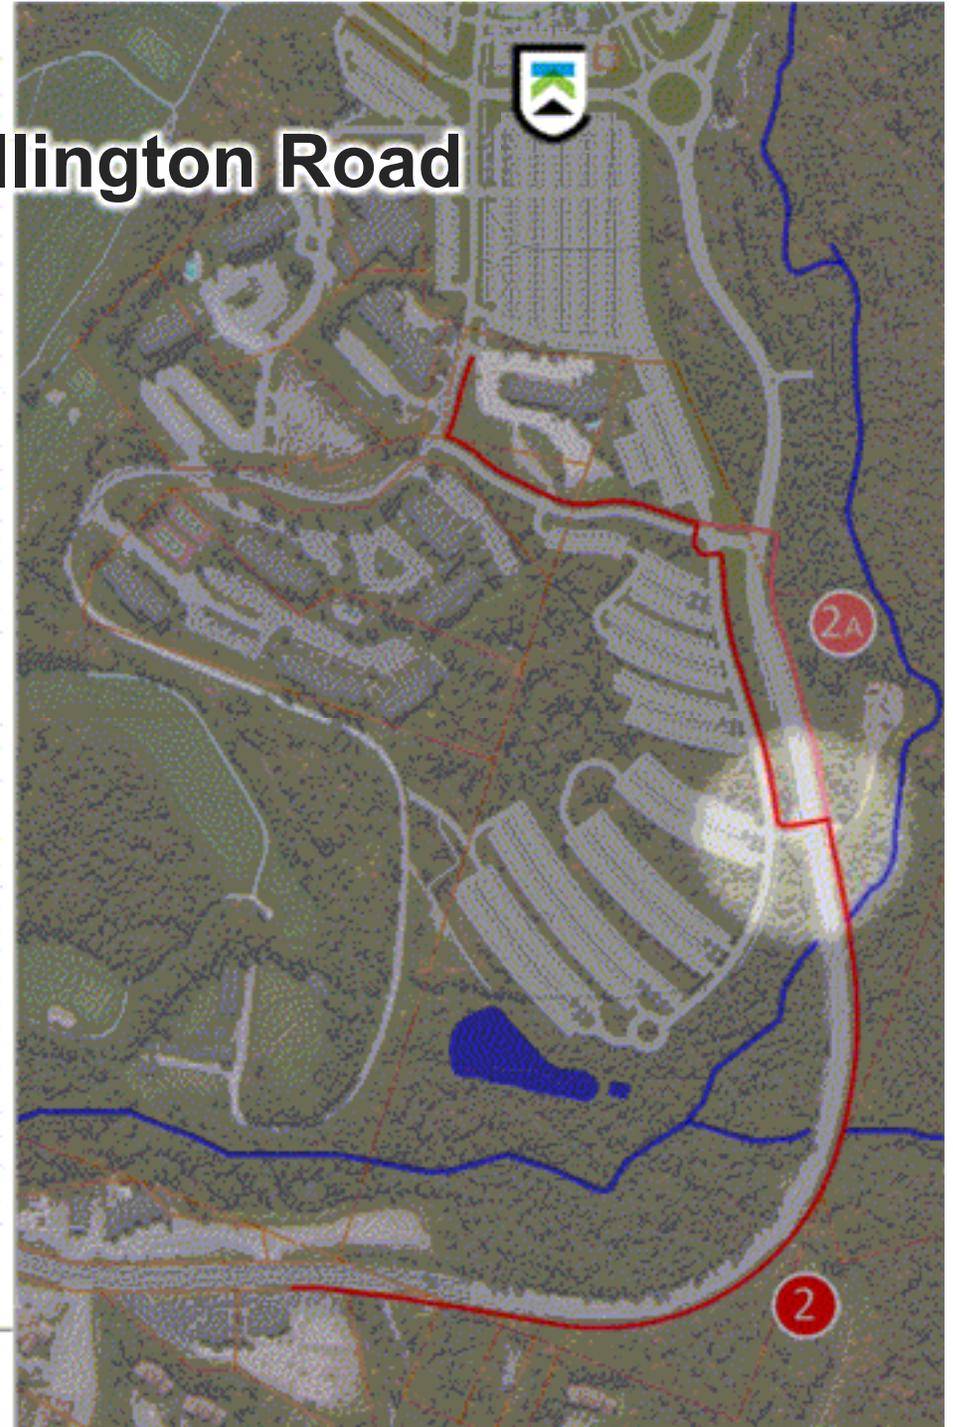
Alignment 2 – Along Killington Road

- Overall Length – 4400 feet
- Continues path along west side of Killington Road, ~5% grade
- Approximately 1650 feet of path travels through resort parking lot
- Behind the existing utility poles; 15-foot green strip
- Historic buffer impact
- Two large stream crossings
 - Assume box culvert extension
 - Impacts to river buffer
- Crosses Killington Road at first drive access
- Alternate 2A:
 - Additional 880 feet
 - Crosses at second drive access

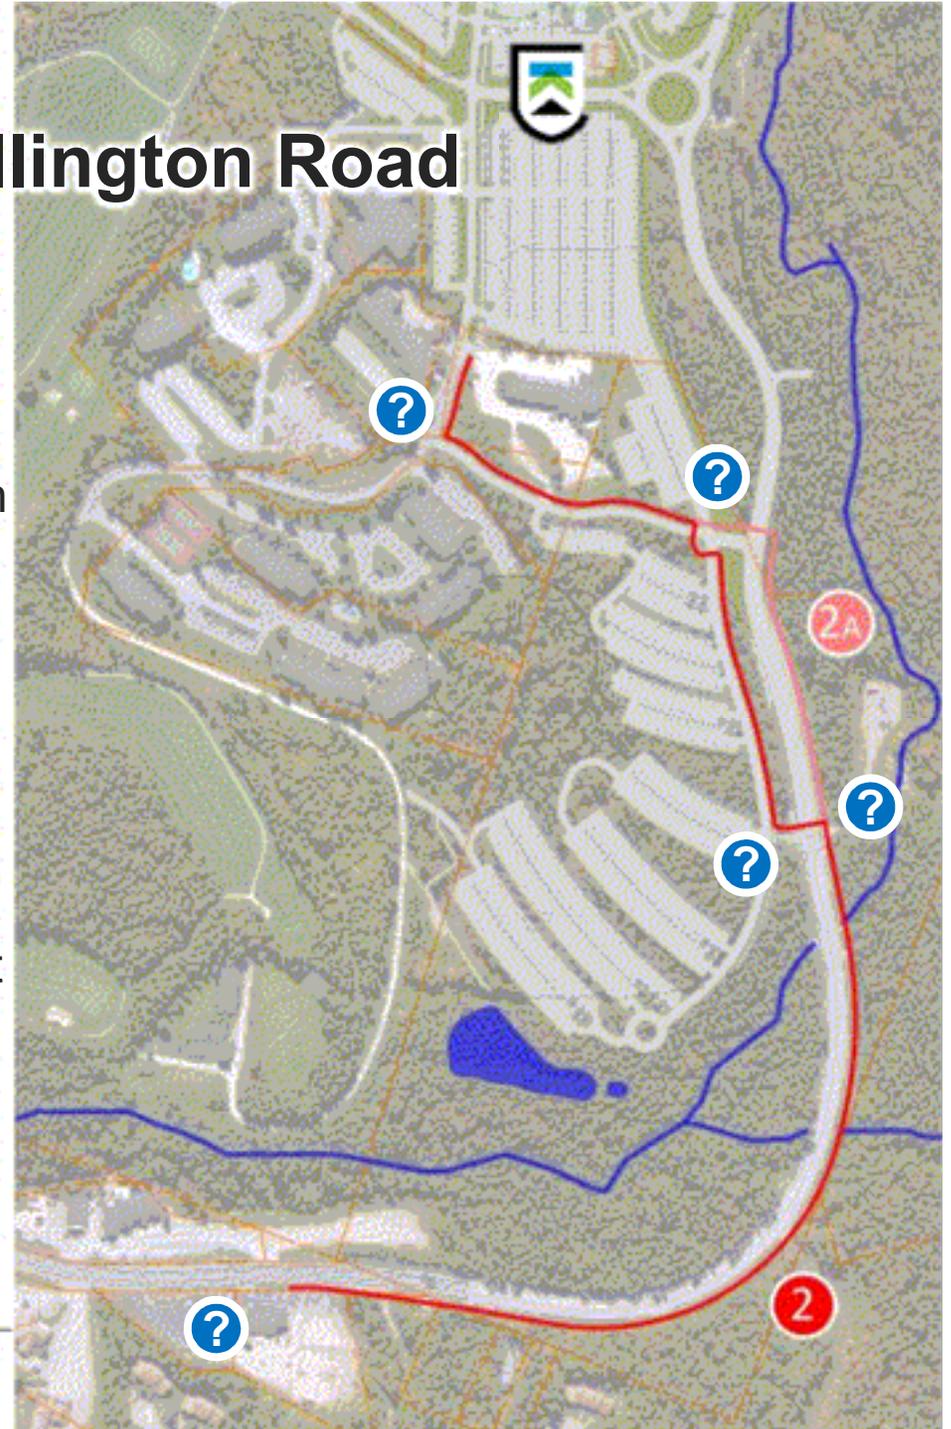
Alignment 2 – Along Killington Road

Less need for wayfinding signs
(but still helpful)

- Directional **arrows**, **mileage**, and **walking time** to destinations at each junction:
 - Resort
 - Commercial District
 - Parking Lots
 - Third Party Properties
 - Shuttle Stops / Shuttle Map
- Walkway is visible from the road, but lighting is still desired

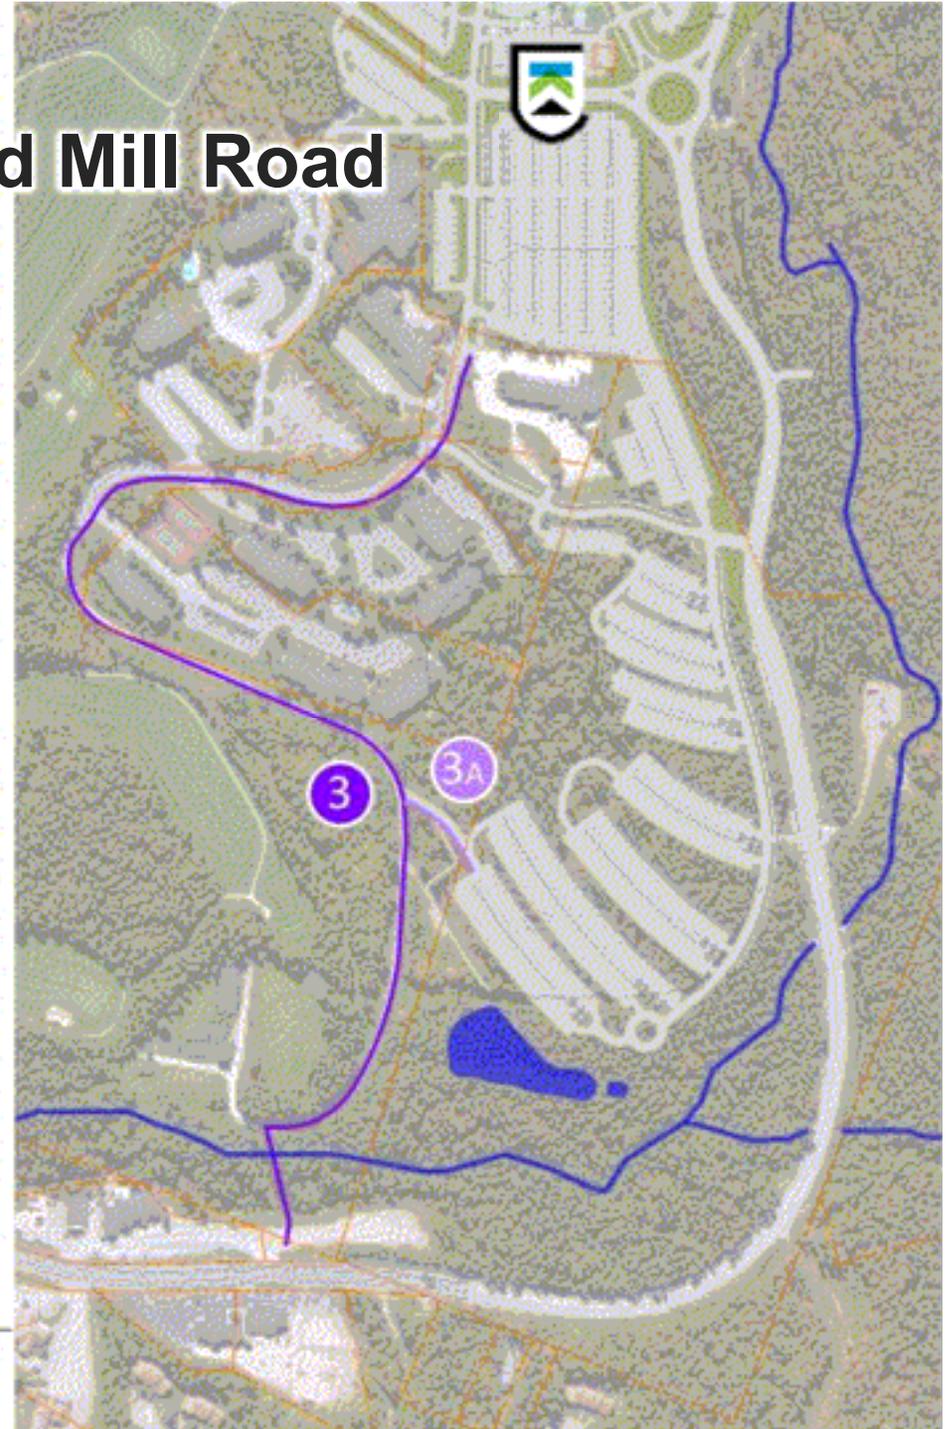
Alignment 3 – Along Old Mill Road

- Overall Length – 4000 feet
- Follows Old Mill Road grade, ~8%
- Approximately 200 feet travels through resort parking lot

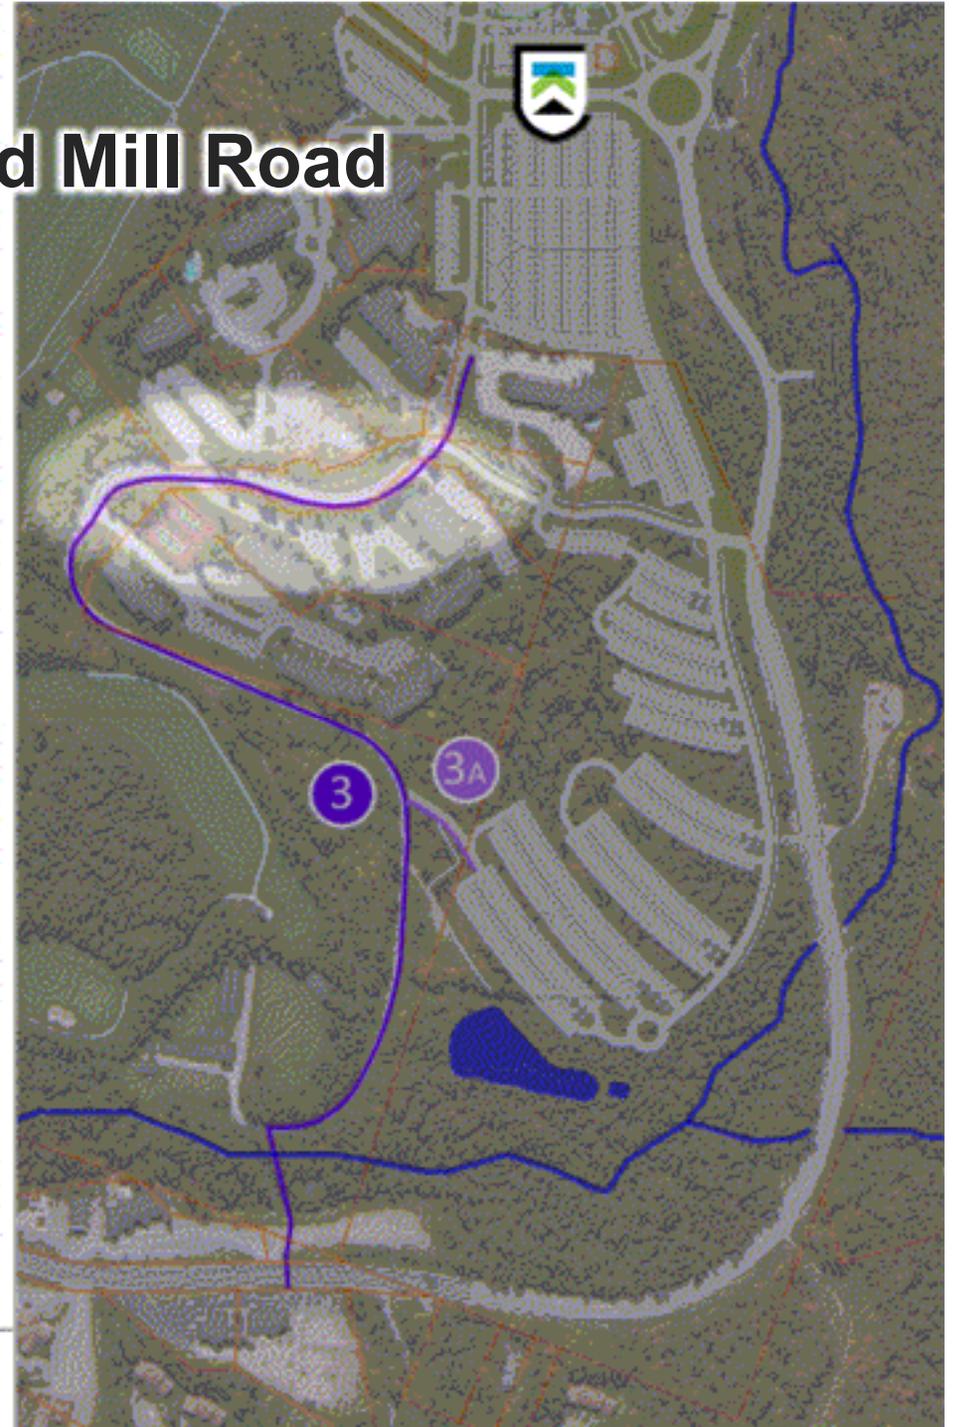
Alignment 3 – Along Old Mill Road

- Overall Length – 4000 feet
- Follows Old Mill Road grade, ~8%
- Approximately 200 feet travels through resort parking lot
- Crosses Killington Road at Lower Crossing Point
- New Stream Crossing
 - Assume 75-foot bridge
 - Impacts to Roaring Brook
 - Follows existing power line cut
- Path to shared on Old Mill Road
- Alternate 3A to connect to resort parking lot, grade ~8%
- Adjacent to Old Mill Road (no green strip) at Pinnacle Condo drives
 - Requires 8-foot retaining wall

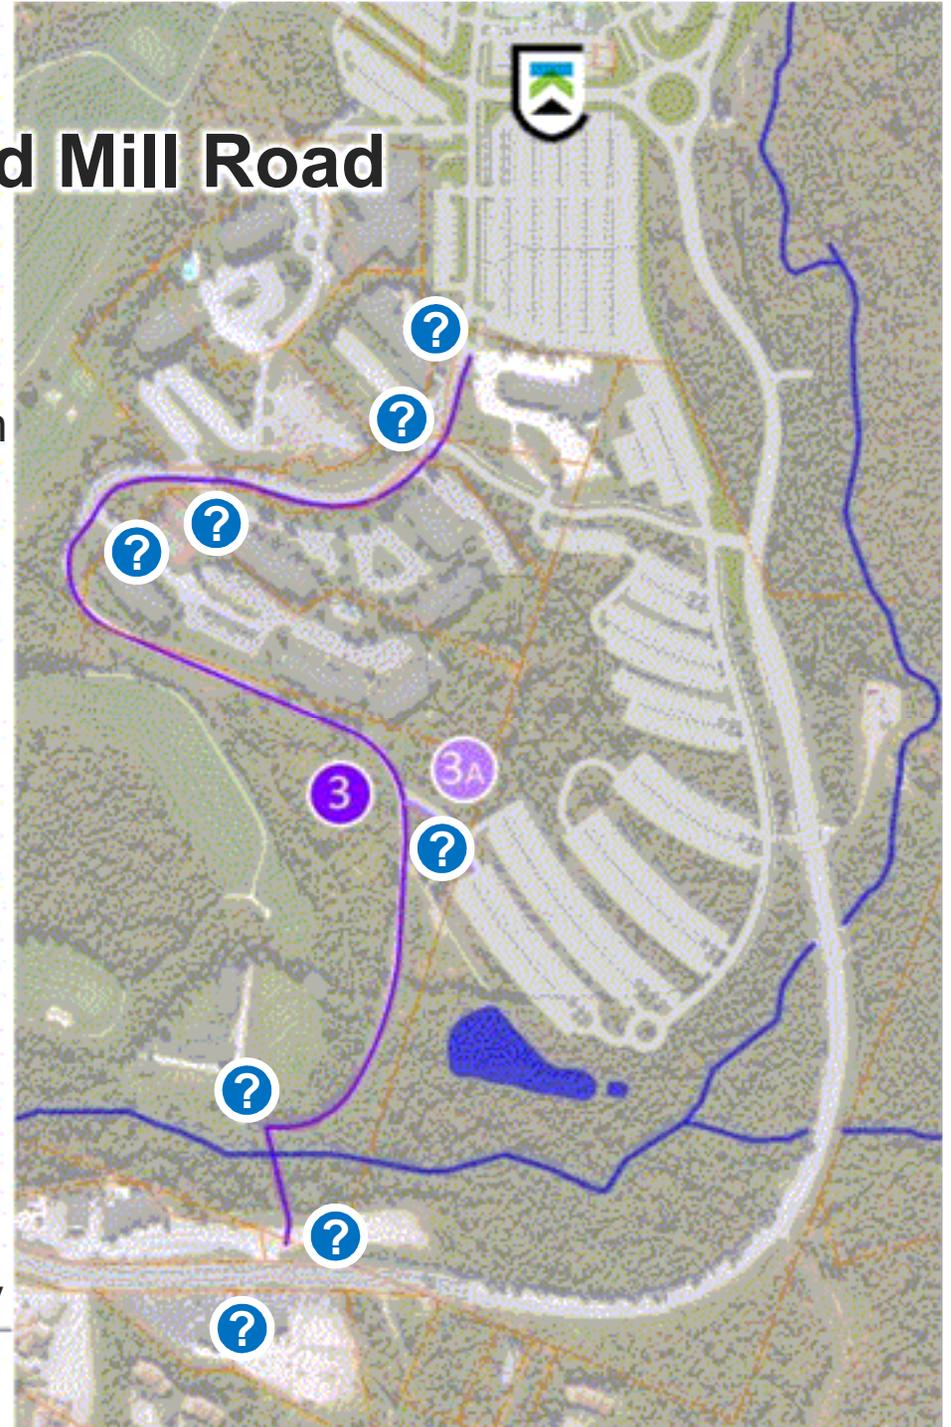
Alignment 3 – Along Old Mill Road

Greatest need for wayfinding signs:

- Directional **arrows**, **mileage**, and **walking time** to destinations at each junction:
 - Resort
 - Commercial District
 - Parking Lots
 - Third Party Properties
 - Shuttle Stops / Shuttle Map
- Educational / Informational signs in between junctions to reinforce path
 - Roaring Brook
 - Flora & Fauna
 - Golf Course / Other Recreation
 - Mountain / Town Facts
- Include lighting along entire walkway

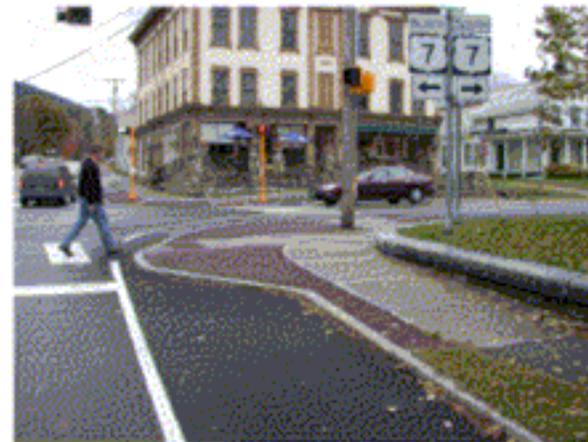
VERMONT AGENCY OF TRANSPORTATION
GUIDELINES FOR PEDESTRIAN CROSSING
TREATMENTS
January 2015 Update

Updated January 2015 - Criteria Includes:

1. Speed Limit 40 mph or less
Speed Limit = 35 mph*
2. Adequate Sight Distance
Increased to 335-feet**
3. No other crosswalks in 200 feet
No other crosswalks
4. Vehicle volume exceeds 3000 vpd
AADT = 4500 vpd
5. Pedestrian Crossing Volume exceeds 20 / hour in the highest hour
Highly seasonal
6. No parking within 20 feet of crosswalk
No parking on Killington Road

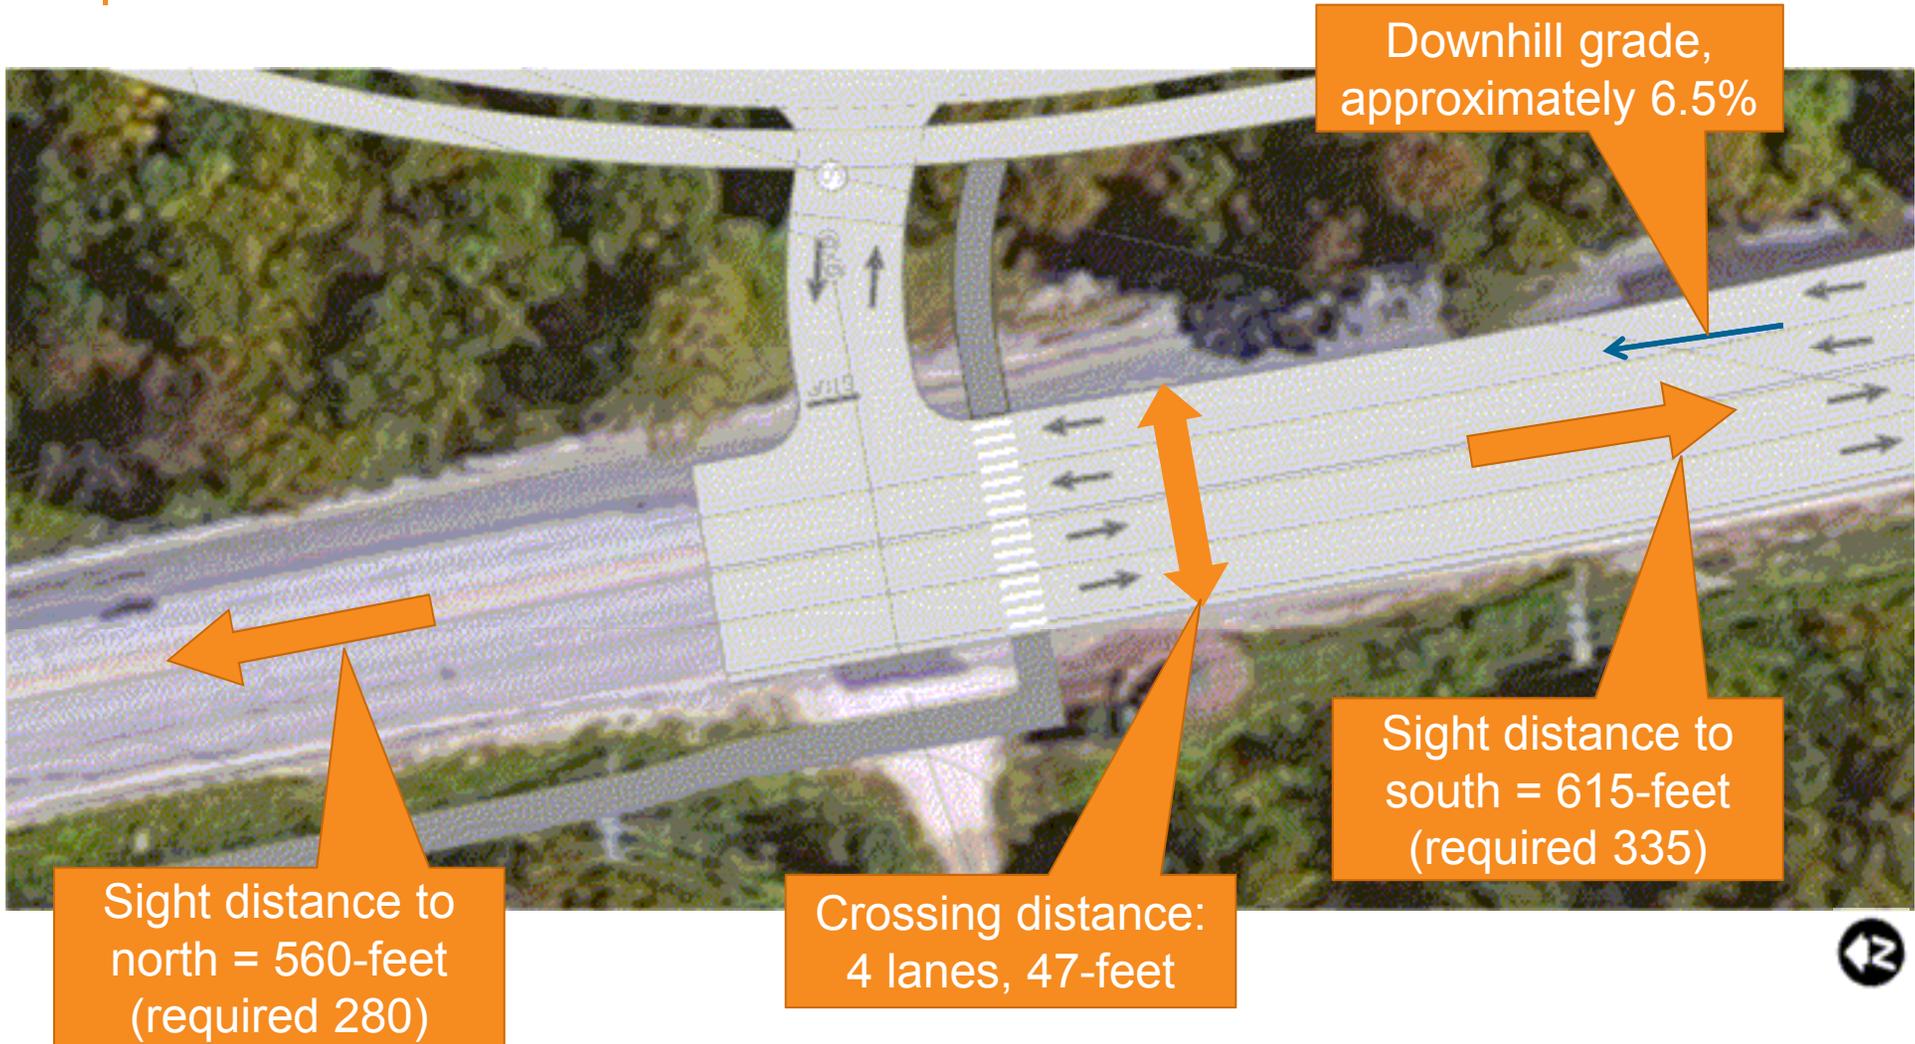
First Drive Crosswalk: Alignment 2

Sight distance to north = 560-feet (required 280)

Crossing distance: 4 lanes, 47-feet

Sight distance to south = 615-feet (required 335)

Downhill grade, approximately 6.5%

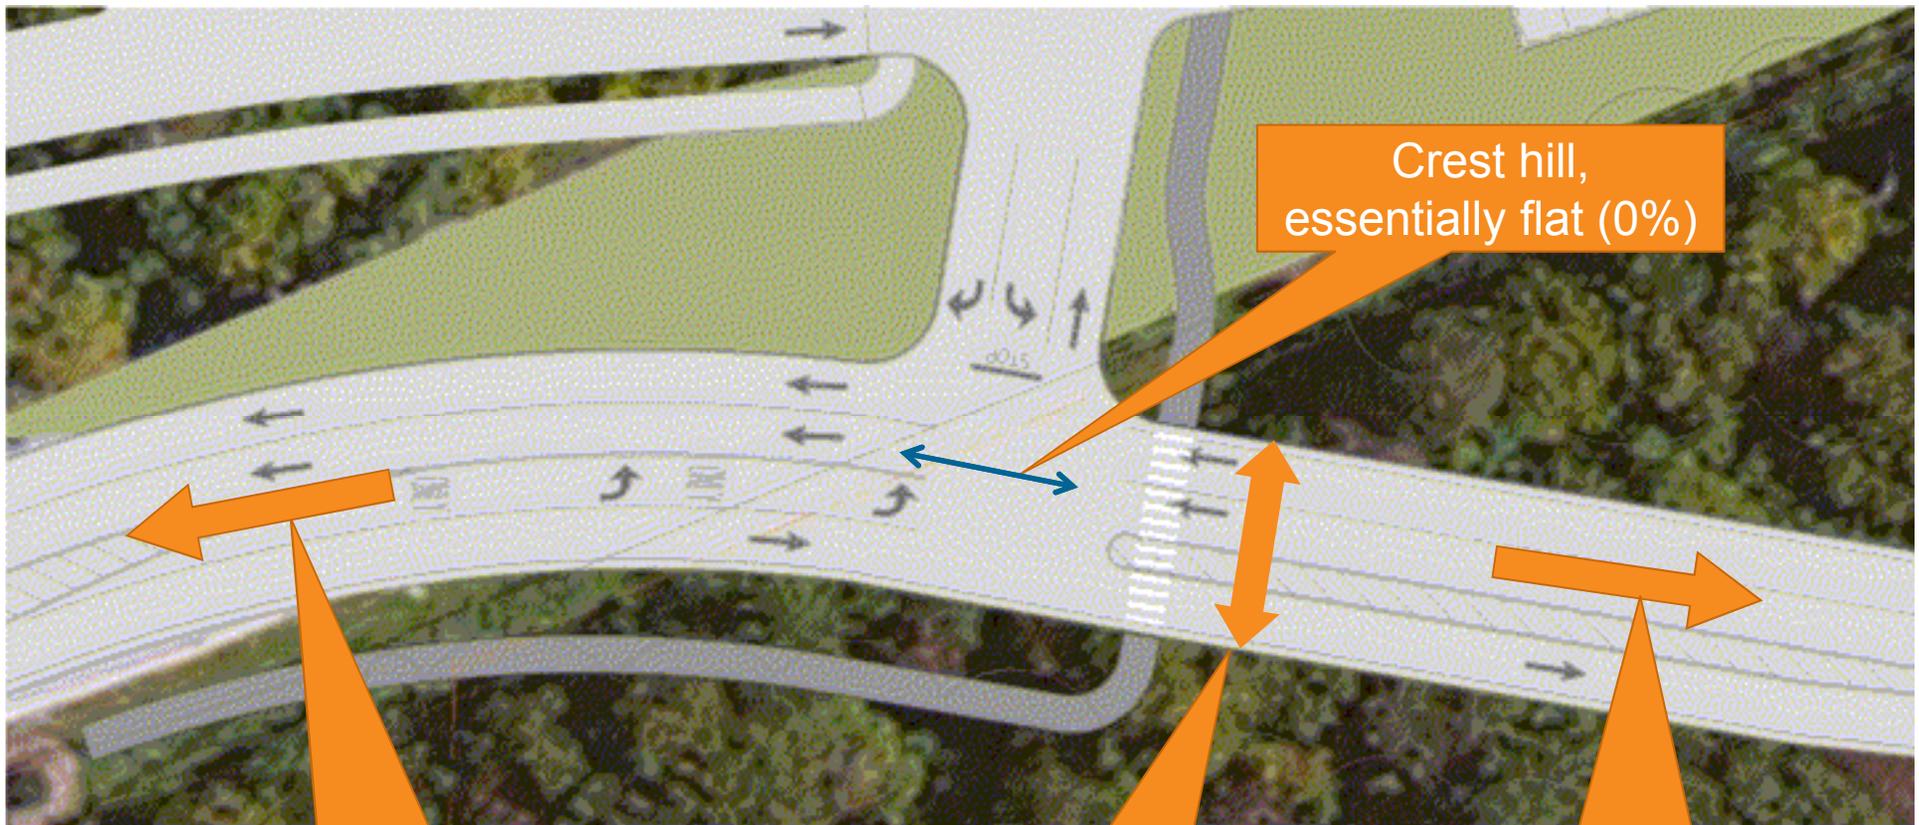
Second Drive Crosswalk: Alignment 3

Crest hill,
essentially flat (0%)

Sight distance to
north = 260-feet
(required 305)

Crossing distance:
3 lanes, 45-feet

Sight distance to
south = 275-feet
(required 305)

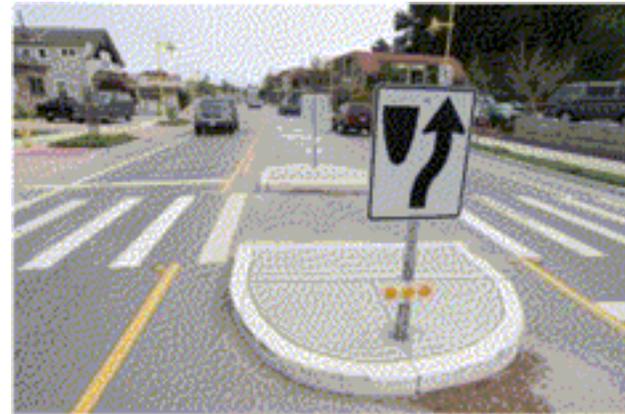
1. Pedestrian Refuge Island

- Reduce the number of lanes to cross at once
- Can help reduce traffic speeds
- Creates plow obstacle

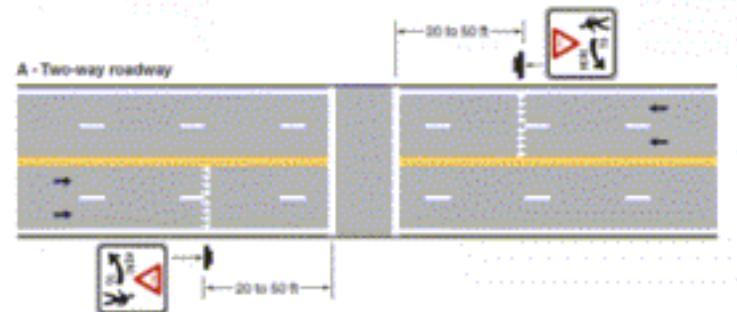
2. Advanced Yield Line

- Stops traffic further back from crosswalk so both lanes can see the pedestrian in crosswalk
- “Multiple-Threat Crash”

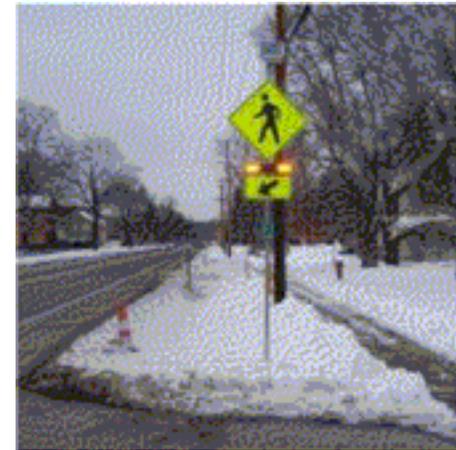
3. Rectangular Rapid Flashing Beacons

- Provides additional emphasis to crosswalk warning signs only when pedestrians are present
- Should be considered where nighttime use is expected

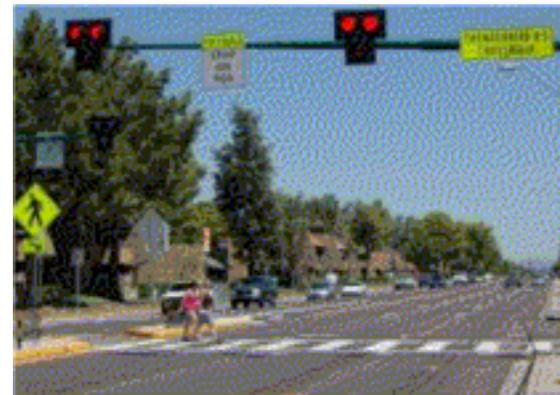
4. Pedestrian Hybrid Beacon (HAWK)

- Pedestrian activated stop light
- Requires substantial investment and pedestrian volume warrant
