Killington Road Walkway Scoping Study

Alternative Presentation Meeting
Town of Killington Planning Commission
May 13, 2015

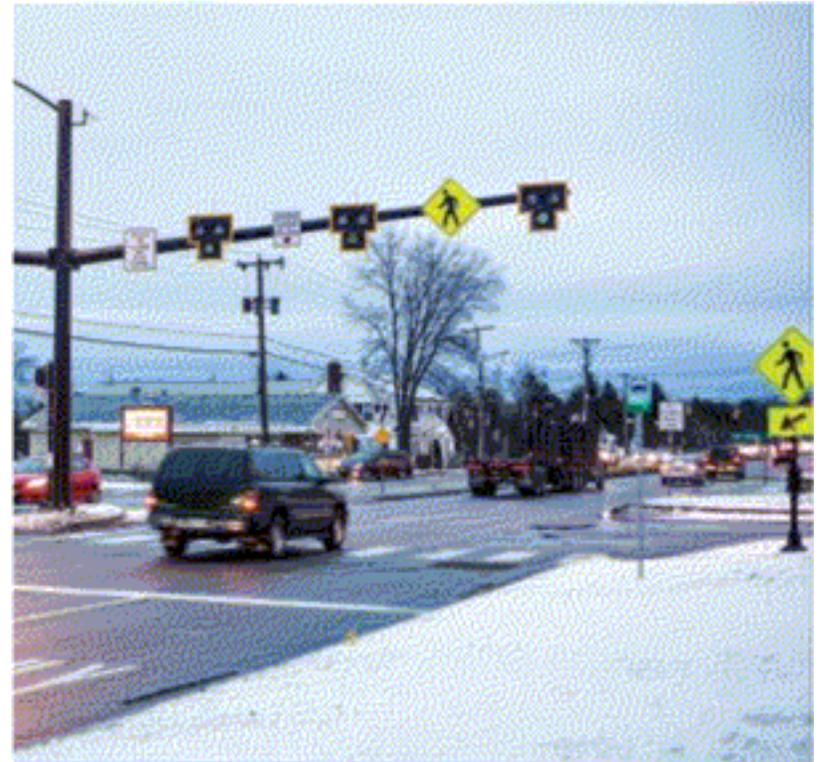
Pedestrian HAWK signal in Colchester

Only the HAWK signal requires a vehicle STOP – other crosswalks require a YIELD.

Modeling a traffic signal condition on the busiest road segment with 60 vehicle (pedestrians) crossings per hour:

Killington Road
Delay	6 s
NB LOS	A
NB Max Queue	191 ft

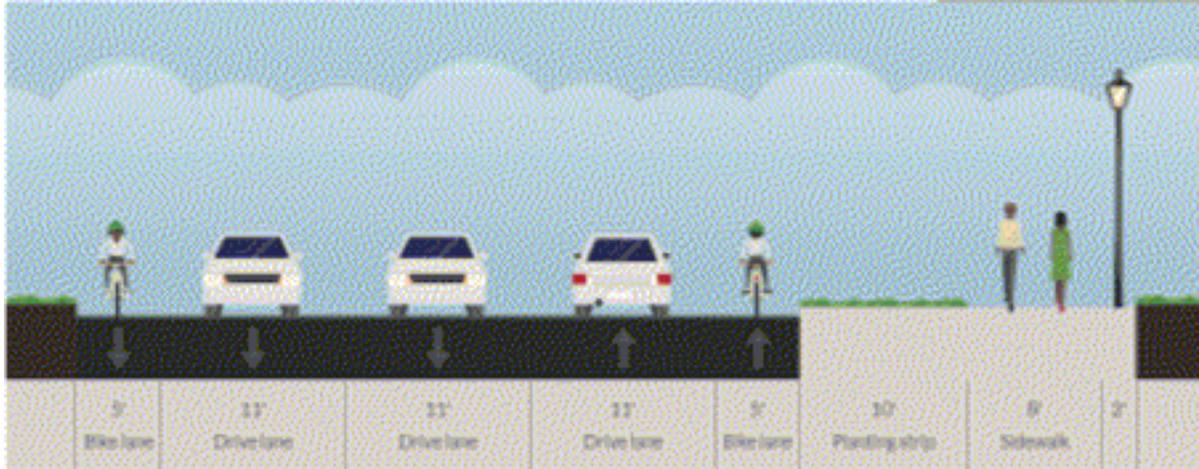
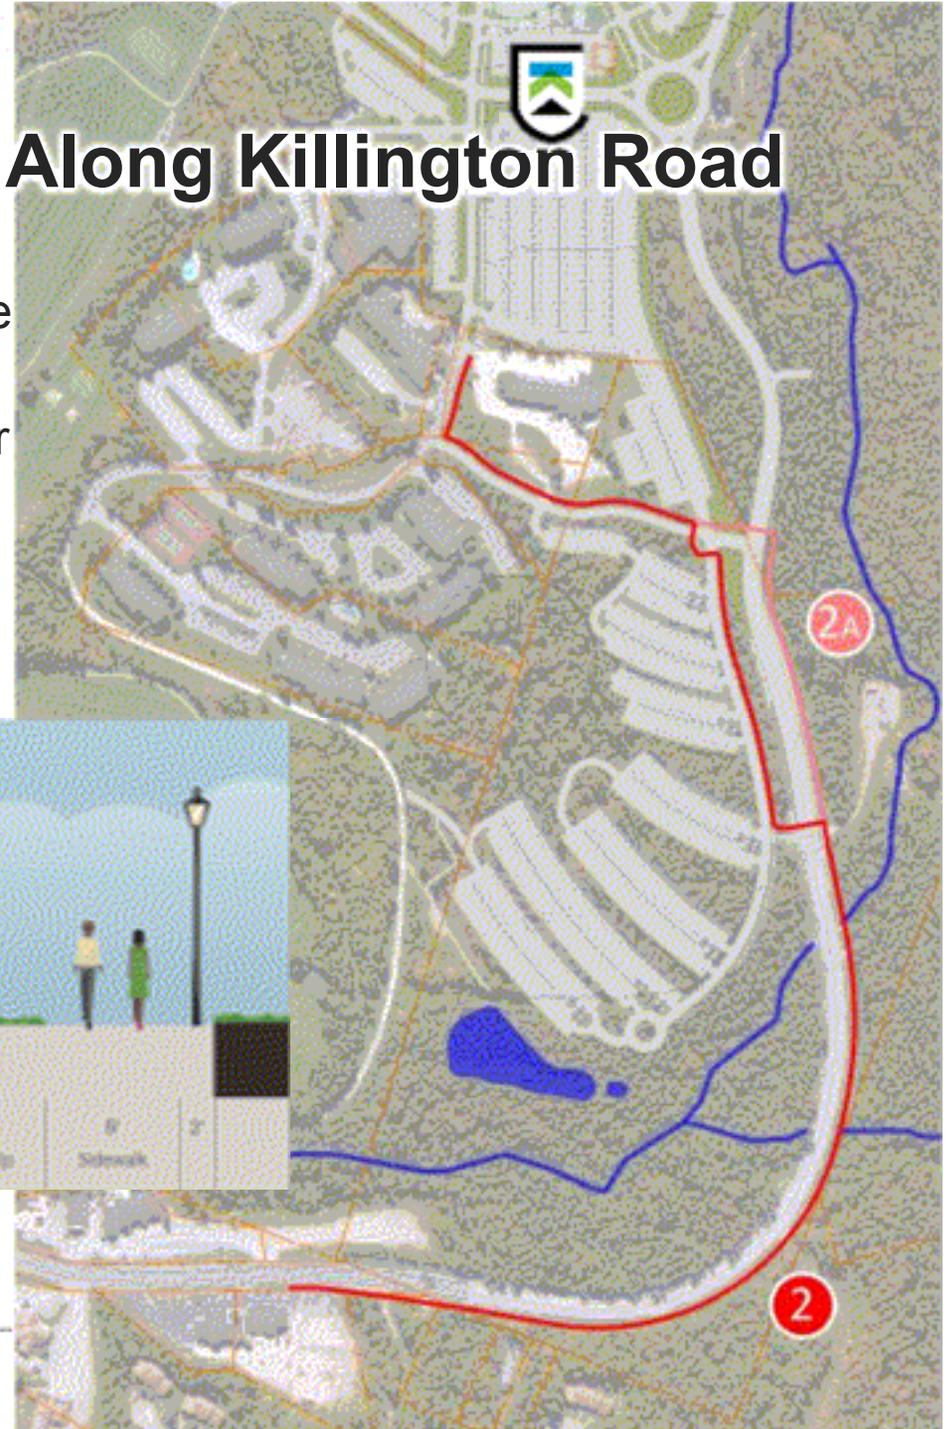
Modified Alignment 2 – Along Killington Road

1. Reduce uphill lanes from two to one
 - Road cross section to include three 11-foot lanes, and two four foot shoulders
 - Walkway offset downslope, 10-feet from shoulder

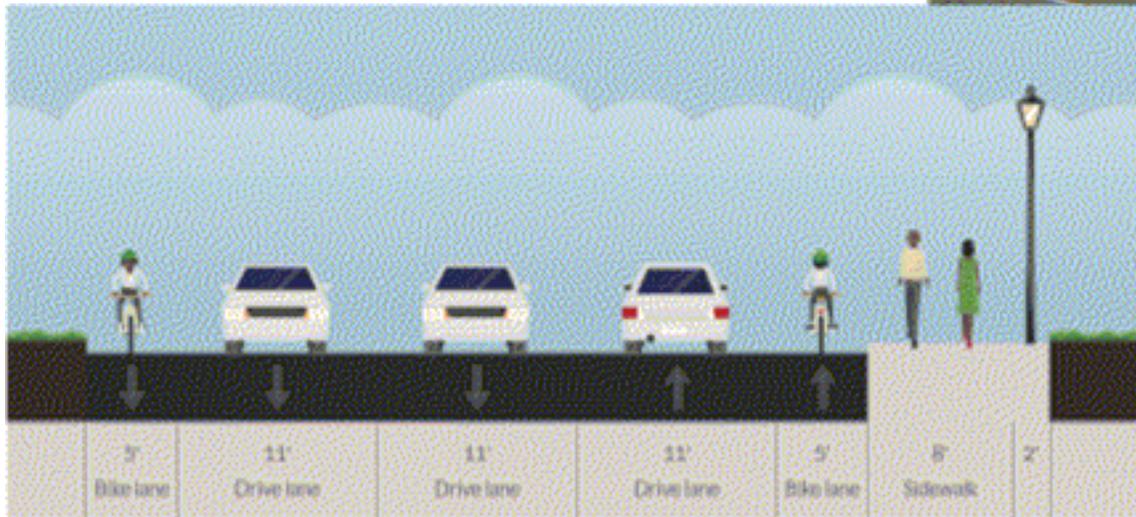
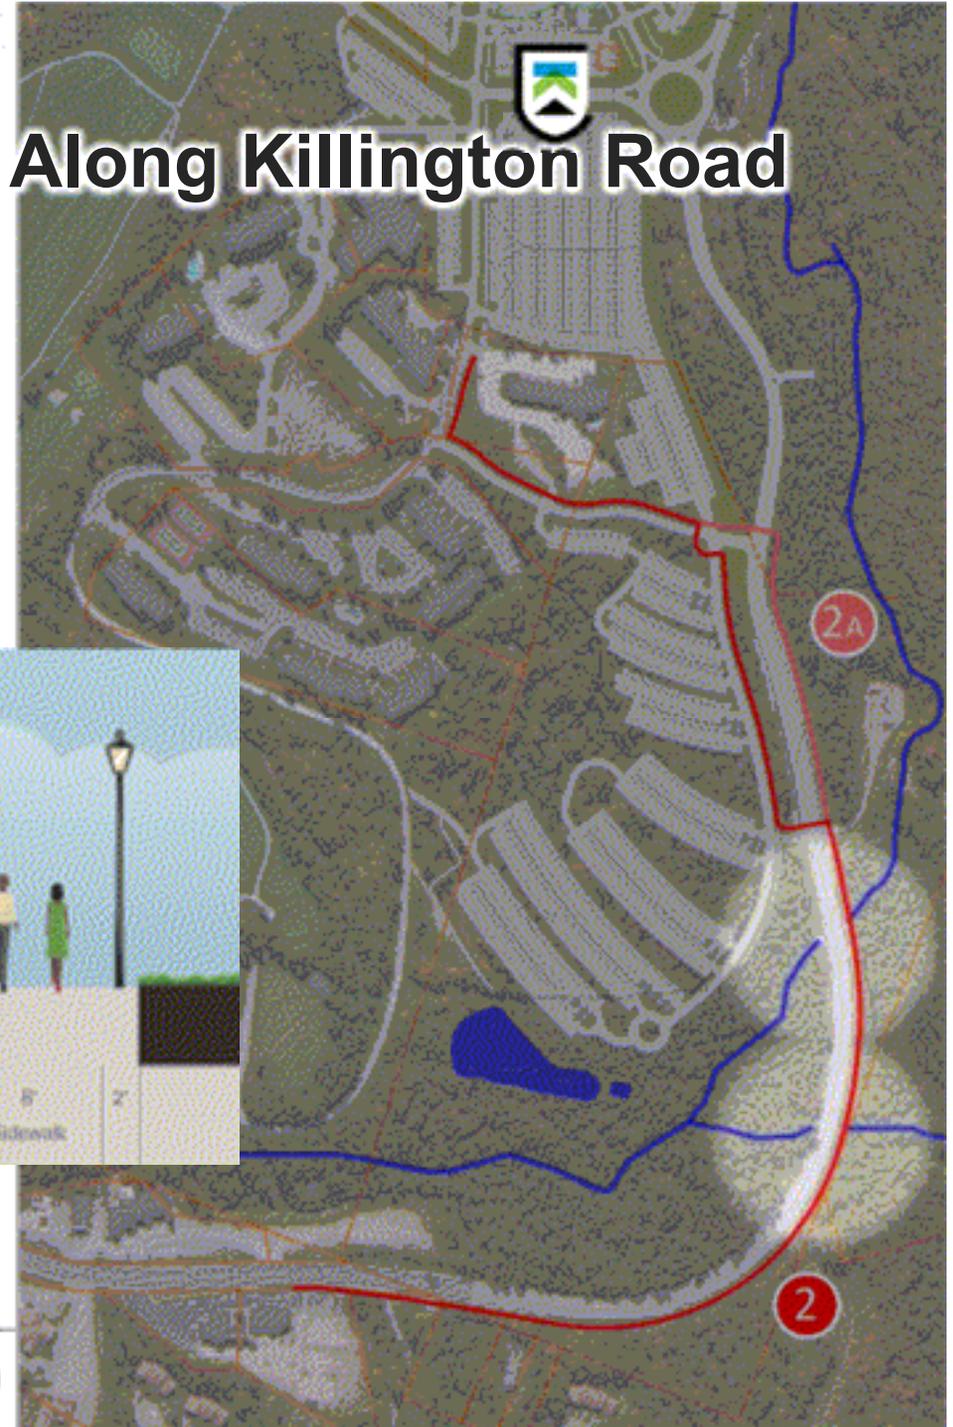
Modified Alignment 2 – Along Killington Road

At river crossings, reduce or fully remove the 10-foot buffer to reduce river impacts

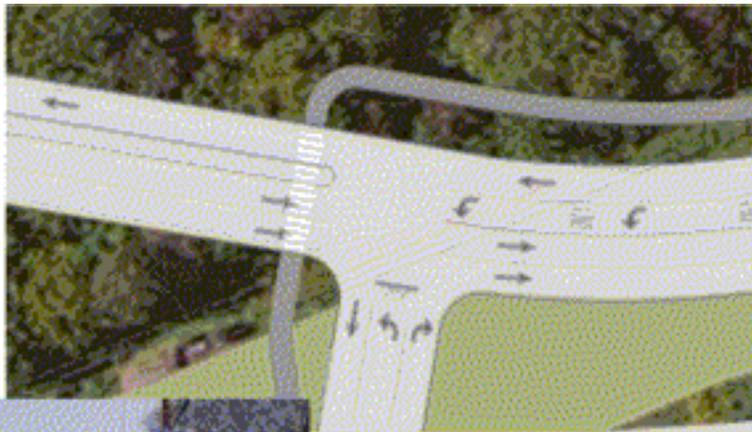
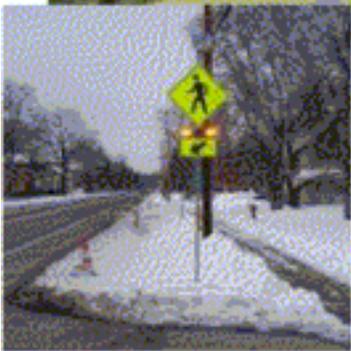
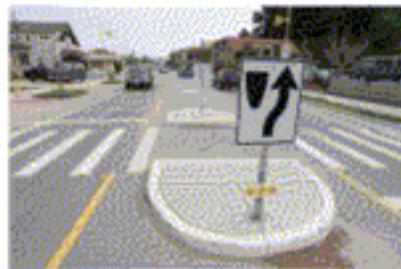
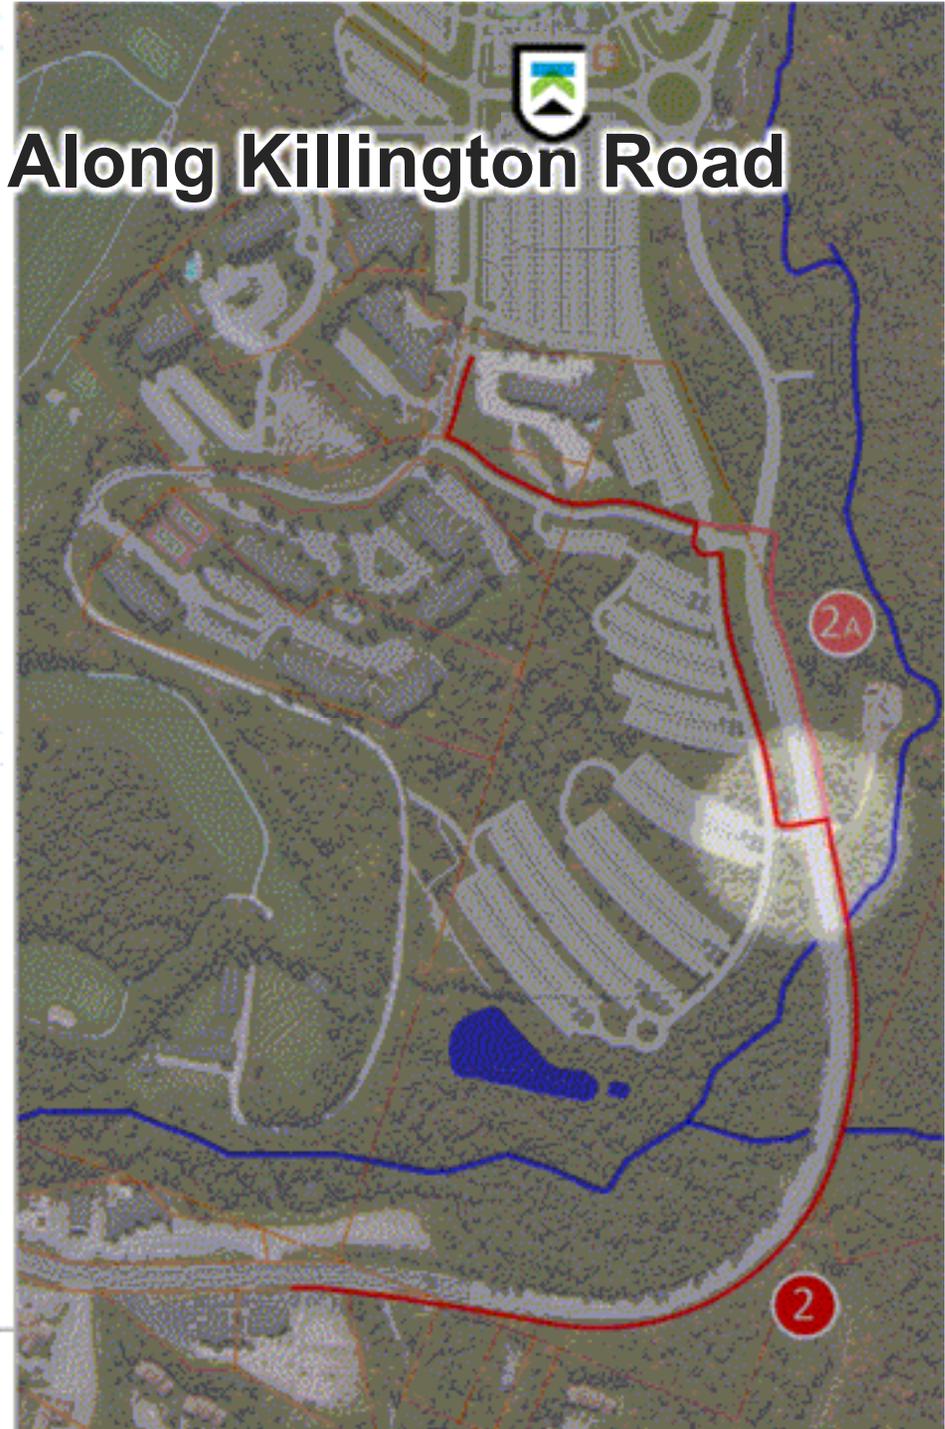
Modified Alignment 2 – Along Killington Road

At crosswalk location, introduce an uphill left turn lane – opposite the left turn lane, include a Pedestrian Refuge Island, RRFB assembly, and advanced yield line
