# Killington Road Master Planning Study

August 26, 2021

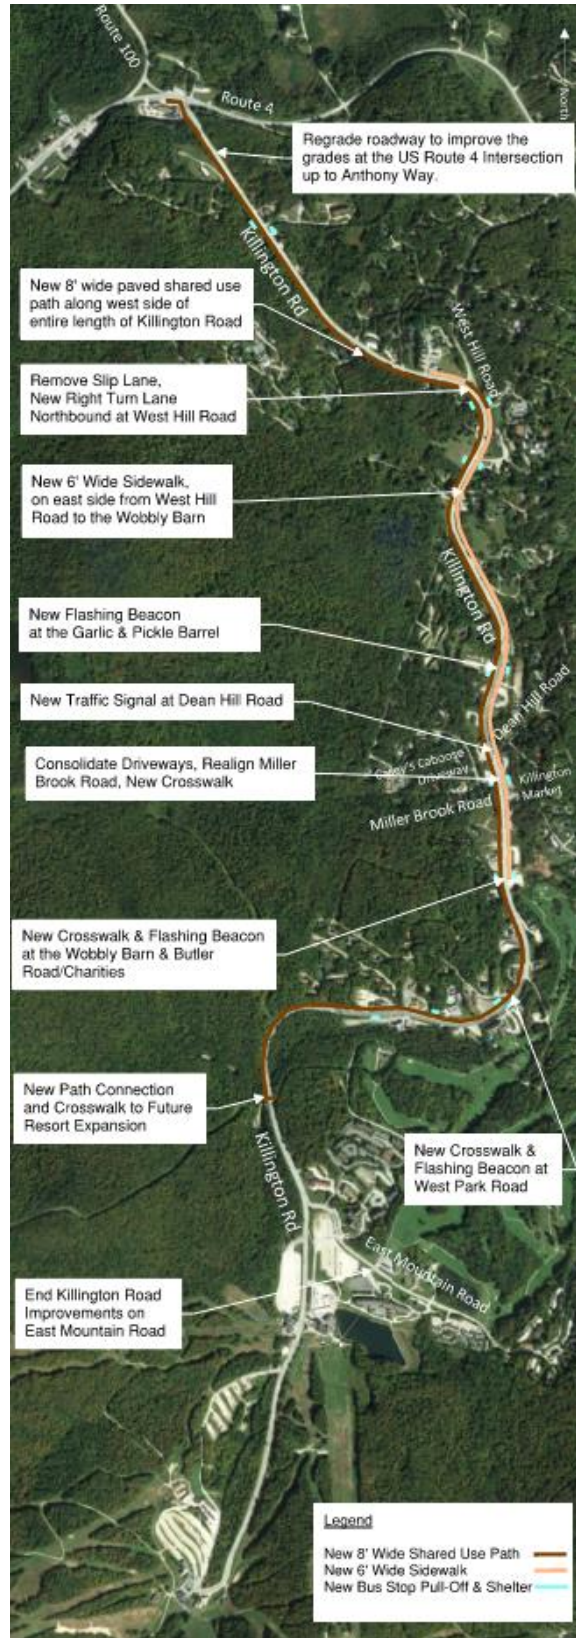
Figure ES1 - Overall Corridor Improvements

Figure ES1 presents a graphic outlining the proposed improvements for the Killington Road corridor. Action items were prioritized into immediate, short-term and long-term recommendations for implementation.

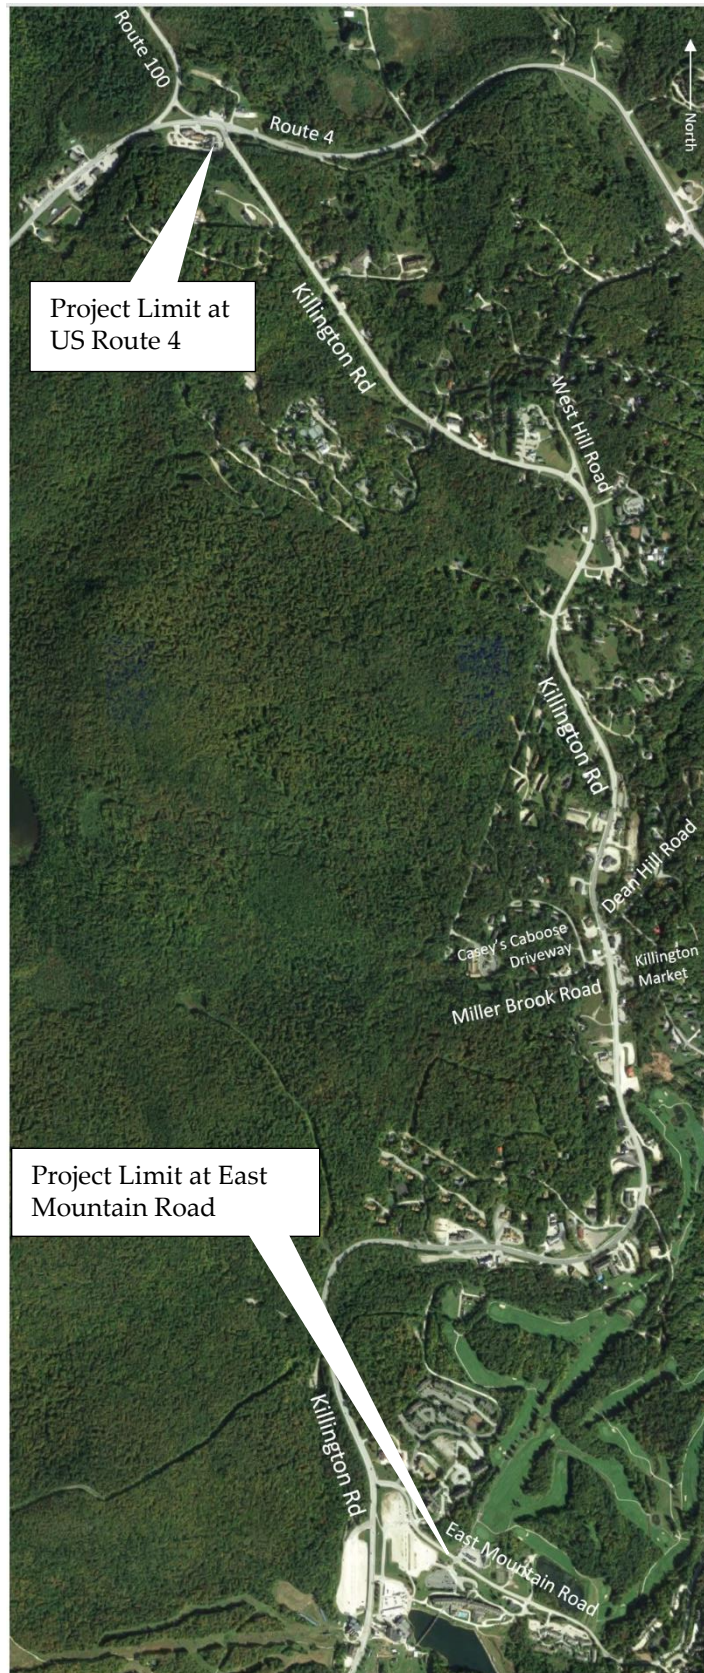
Figure 1 - Study Area

As shown in Figure 1 on the following page, the Killington Road study area extends from its intersection with US Route 4 and VT Route 100 to a point approximately 3.6 miles south, where Killington Road intersects with East Mountain Road, and extends 0.2 miles on East Mountain Road. An inventory of the existing conditions at each of the study area intersections is provided in the next chapter. Currently, two short segments approximately 0.6 mile long at the south end of Killington Road and  $\frac{1}{4}$  long at the west end of East Mountain Road are not owned by the Town, but are part of the Resort and SP Land Company, LLC (SP Land) property.

at the Resort. The project study area ends at the Town-owned portion of East Mountain Road near the Killington Grand Hotel as shown in Figure 1. Currently, two short segments approximately 0.6 mile long at the south end of Killington Road and ¼ long at the west end of East Mountain Road are not owned by the Town, but are part of the Resort and SP Land's property.

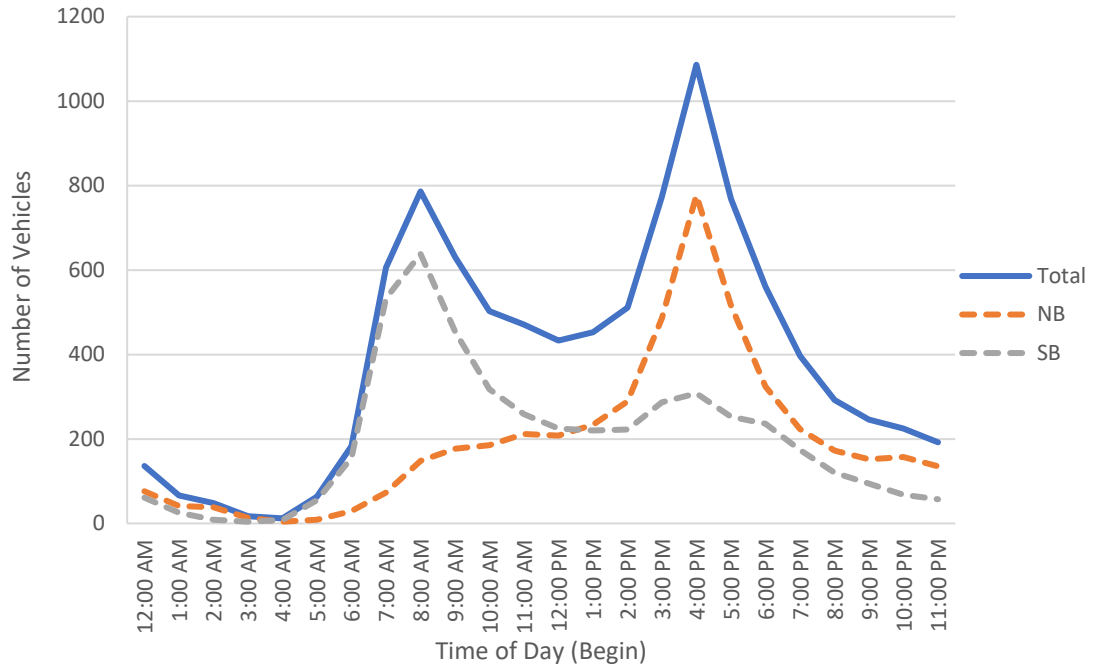
**Figure 2 - Killington Road Weekday Hourly Demand Fluctuation**

Figure 2 presents the hourly variation of Killington Road by direction over a Saturday in February. As shown, Killington Road southbound peaks in the morning and Killington Road northbound peaks in the evening. This is most likely due to vehicles headed to the Resort in the morning and leaving the Resort in the evening.

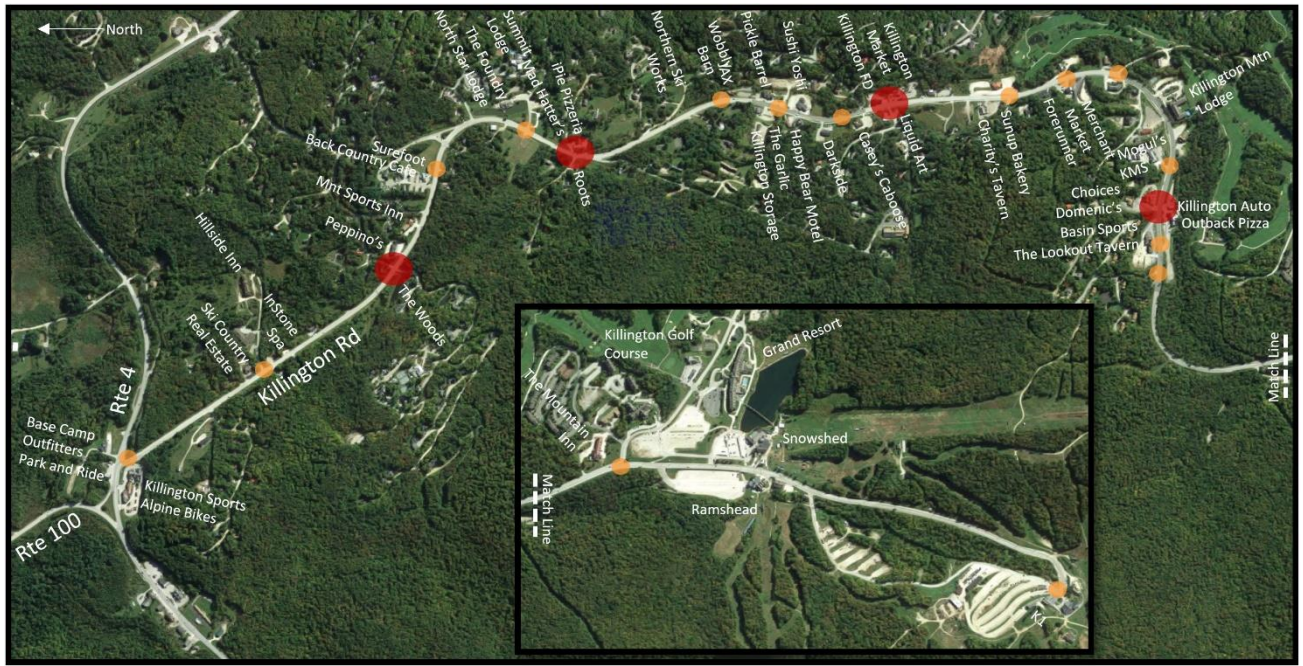
**Figure 3 - Killington Road Crash Summary**

In order to identify crash trends, safety concerns, and/or roadway deficiencies within the study area, crash data were obtained from VTrans for the five-year time period from January 1, 2015 to December 31, 2019 along the length of Killington Road. A summary of the crash data is presented in Table 3 and a summary of crashes by location is depicted in Figure 3. Locations with one crash over the five year period are indicated by an orange circle while locations with two crashes over the five year period are indicated by a red circle in Figure 3.

The table shows that a total of 40 crashes occurred during the five-year period from 2015 to 2019. The highest density of crashes occurred between Schoolhouse Road and the Glazebrook Townhouses. This is not surprising because this segment runs through the business district where there are frequent driveways on both sides of the road. The four project intersections were examined, and it was found that over five years, there were only four crashes. The intersection with US Route 4 at the northern end of Killington Road saw five crashes over five years.

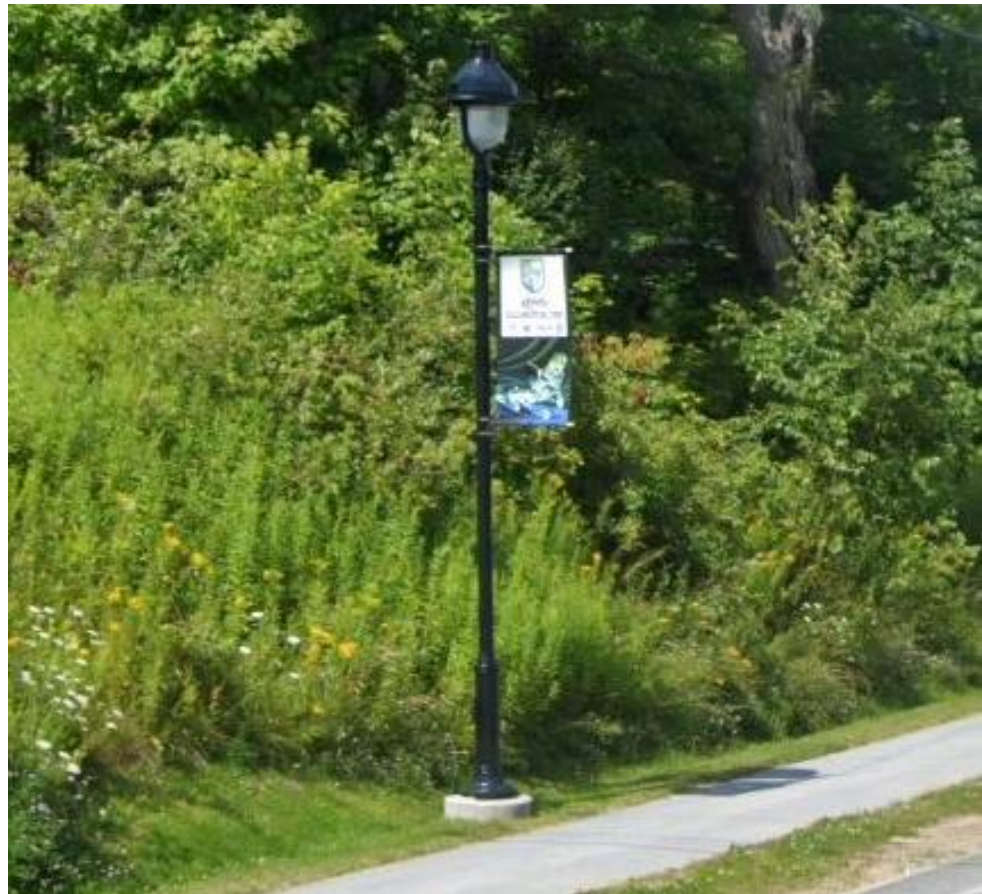
**Figure 5 - Existing Lighting Fixtures along Pedestrian Path**

An example of the existing Killington Road lighting that is consistent with these recommendations for Killington Road is presented in 5.

Although lighting exists along the Killington Road corridor, the lighting is inconsistent and in sections outdated and inadequate for the current users. With increased demand to accommodate all modes of travel, and the proposed pedestrian and bicycle facilities and crossings, the lighting for the corridor will become critical from a visibility and personal safety perspective. The lighting recommendation is similar to the lighting fixtures installed along the pedestrian path between West Hill Road and School House Road as shown in 5. This pedestrian scale lighting is proposed along both the shared use path along the west side, and the sidewalk proposed on the east side of Killington Road. Approximately 300 new fixtures would be required and they would be installed every 75 feet along the path and sidewalk, resulting in a total lighting cost of \$2.664 million.

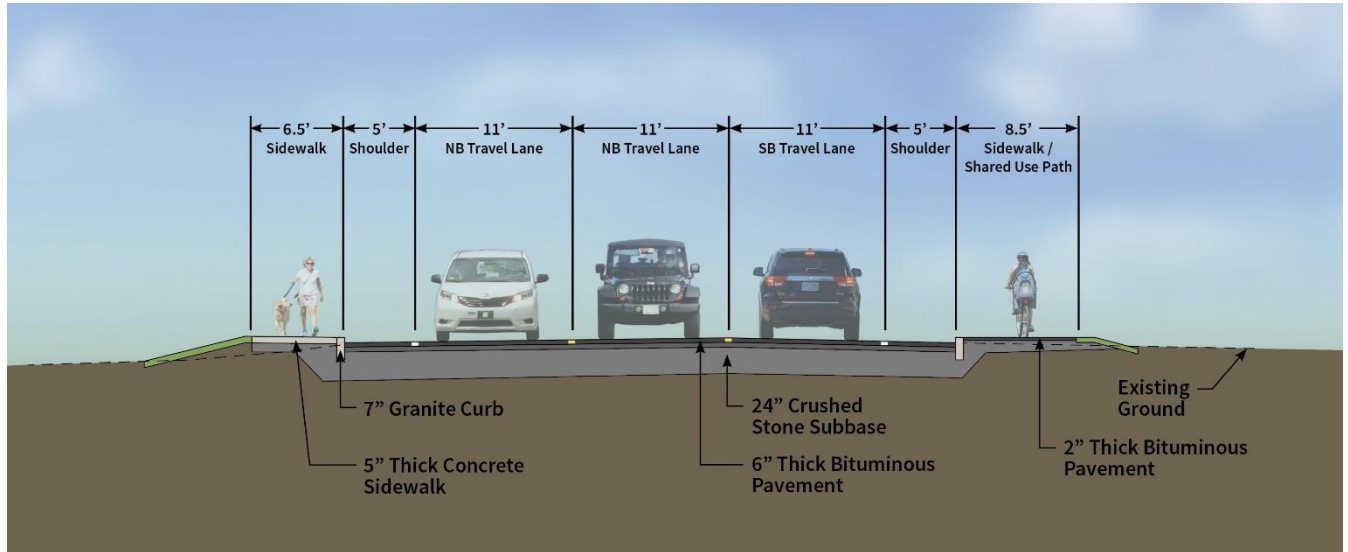
**Figure 6 - Typical Cross Section**

The typical cross section (Figure 6 on next page) will include three 11-foot wide lanes for vehicular traffic with 5-foot shoulders, and the 8.5-foot wide sidewalk to the west (including a 6" wide curb) and a 6.5-foot wide sidewalk (including a 6" wide curb) to the east for a total proposed width of 58-feet. At certain locations, retaining walls or permanent easements may be required to accommodate the proposed cross section, including through lanes for traffic and bicycle and pedestrian accommodation. The reconstruction of the road will require temporary construction easements on both sides in many locations to provide an adequate work area for the contractor, and to tie-in side slopes, etc.
