ARCHITECTURAL ASSESSMENT

The current facility was constructed at three different times:

- 1974 – Original
- 1984 – Middle bays
- 1998 – Apparatus Bay for Tower

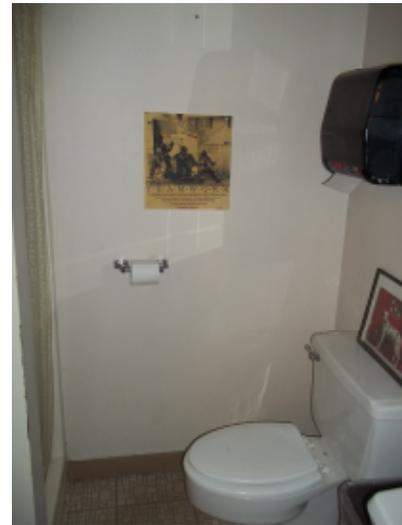
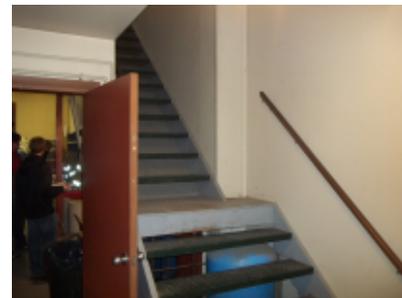
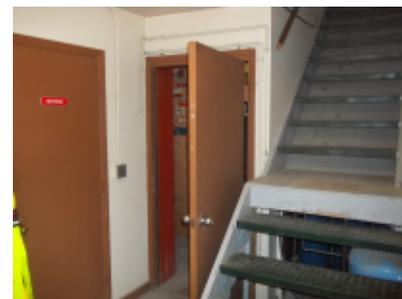
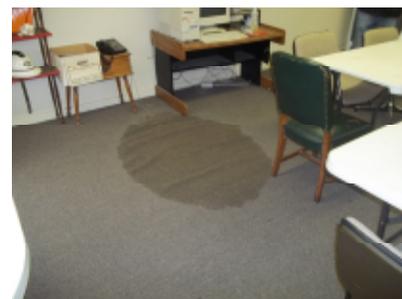
- The single Toilet/ Shower Room is not ADA compliant.
- This toilet room is too small to allow for wheel chair turning radius
- Grab bars are not installed
- The Showers is too small and does not have grab bars and adjustable shower heads
- Many Corridors do not allow for wheelchair turn around
- Access to the door ways are too narrow
- Width of doors are too narrow
- The Kitchen should be ADA compliant with the required countertop height.
- There is no elevator to the second floor. Since this is a public Building paid for by public funds, it is a Title II building which requires the entire building to be handicap accessible. This means adding and elevator for access to the second floor.

- Each of the inaccessible features listed above has an impact on the ability of disabled members of the community to access various spaces independently if needed. Any renovation or new construction plans should incorporate the accessibility of these items to accommodate disabled people.

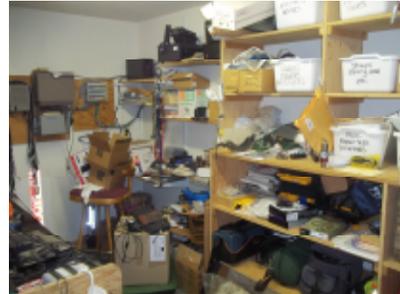
- There is only a single stairway to the second floor. There should be two means of egress due to the occupant load.
- The stairway does not comply with current railing requirements
- Light levels seem low. Corridors do not have adequate egress signage
- Building is not sprinklered. If any additions are planned, the entire building should be sprinklered
- There are steps between Apparatus bays. These have not been constructed per building code and pose a safety hazard especially when responding to emergencies
- The Kitchen does not have a fire protected range hood. If anything is being fried at the station, the building code requires a fire suppression system over the range

- Remove all stored items from Corridors and Hallways
- Update lighting and exit signage.
- Provide a sprinkler system throughout the entire building.
- Provide ramps if possible between the different floor levels

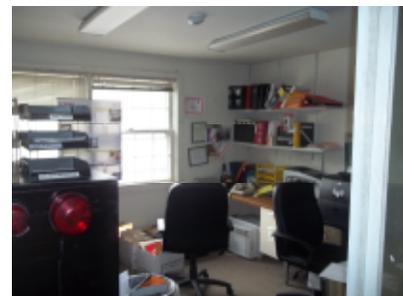
- There is not enough general storage space.
- There is an outdoor storage container that stores salt, hoses and other misc. items

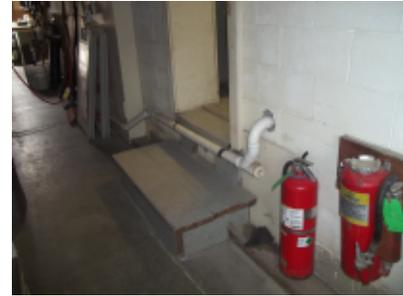
- Turn Out Gear Locker area appears to be inadequate in size for all the personnel
- There are no personnel lockers which is found in many fire stations
- Turn Out Gear Lockers should not be located within the Apparatus Bays due to accelerated degradation of the gear due to vehicle exhaust.

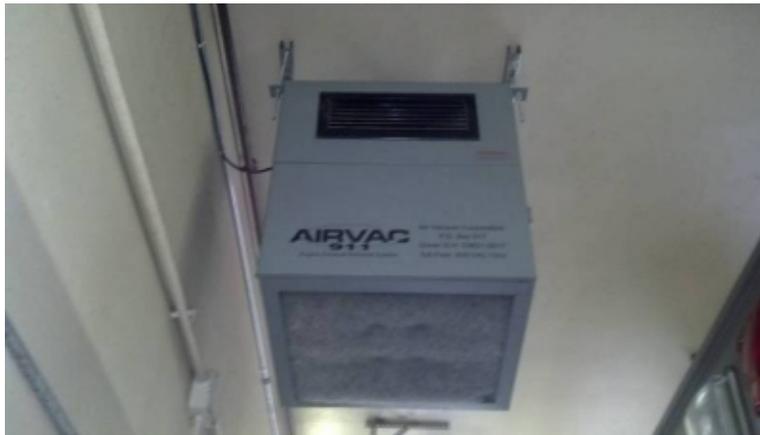
Air Vac 911 for Carbon Monoxide

- The fire department uses about 3,600 gallons of propane per year. There are two (2) 1,000 gallon underground storage tanks in the back.
- There is no central cooling. The only air conditioning is an LG window unit in the meeting room on the second floor. This unit is fairly new and is an energy efficient model (18,000 btu/hr, 10.7 EER).
- There is no central ventilation system. Carbon monoxide units are Air Vac 911 models. Several are installed in the three (3) engine bays.

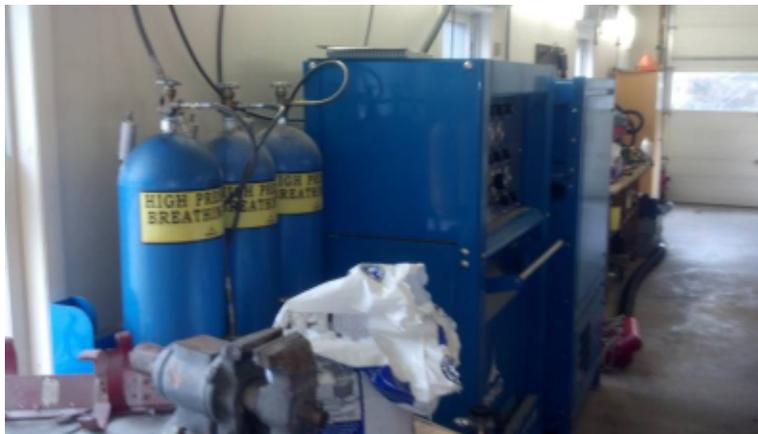
Air Compressor

- An air compressor is piped throughout the engine bays to pneumatic hose reels. This same compressor is used to fill the departments Scot Packs.
